Shorted wiring/forward cargo door rupture/explosive decompression/inflight breakup explanation described in pictures, text, and drawings for United Airlines Flight 811, Pan Am Flight 103, Air India Flight 182, and Trans World Airlines Flight 800.

John Barry Smith 22 March 2002

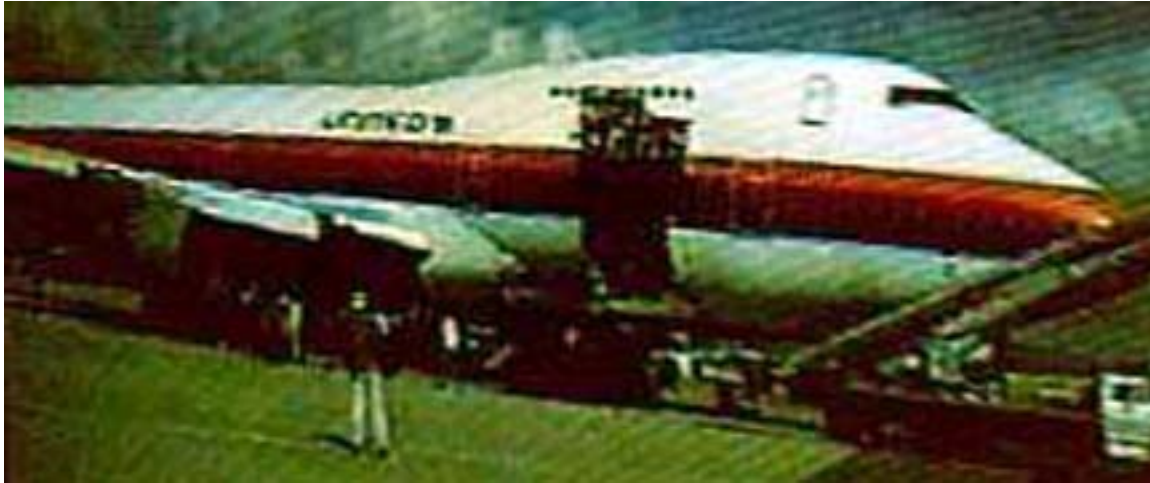
Caption for above photograph: Photo of hole in United Airlines Flight 811 made by inadvertent opening of forward cargo door in flight.

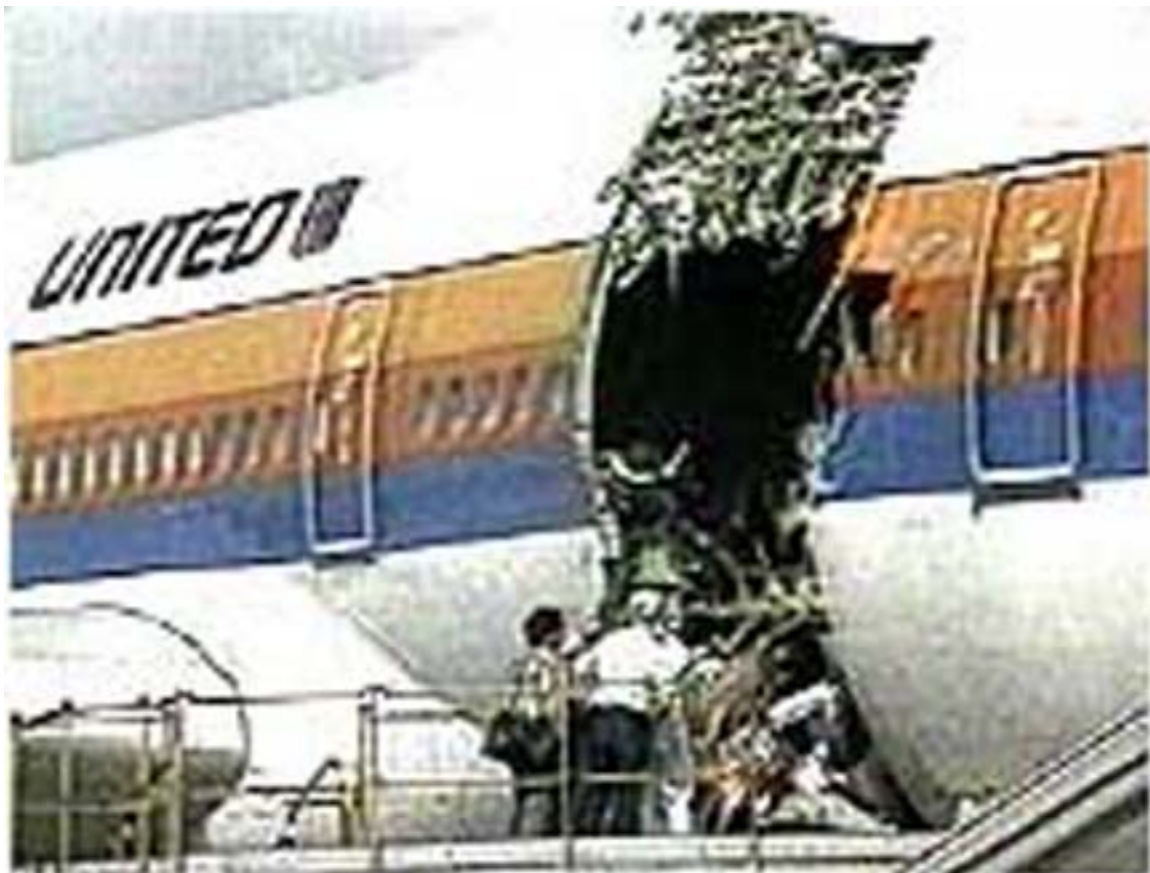
Caption for above photograph: Photo of hole in United Airlines Flight 811 made by inadvertent opening of forward cargo door in flight.

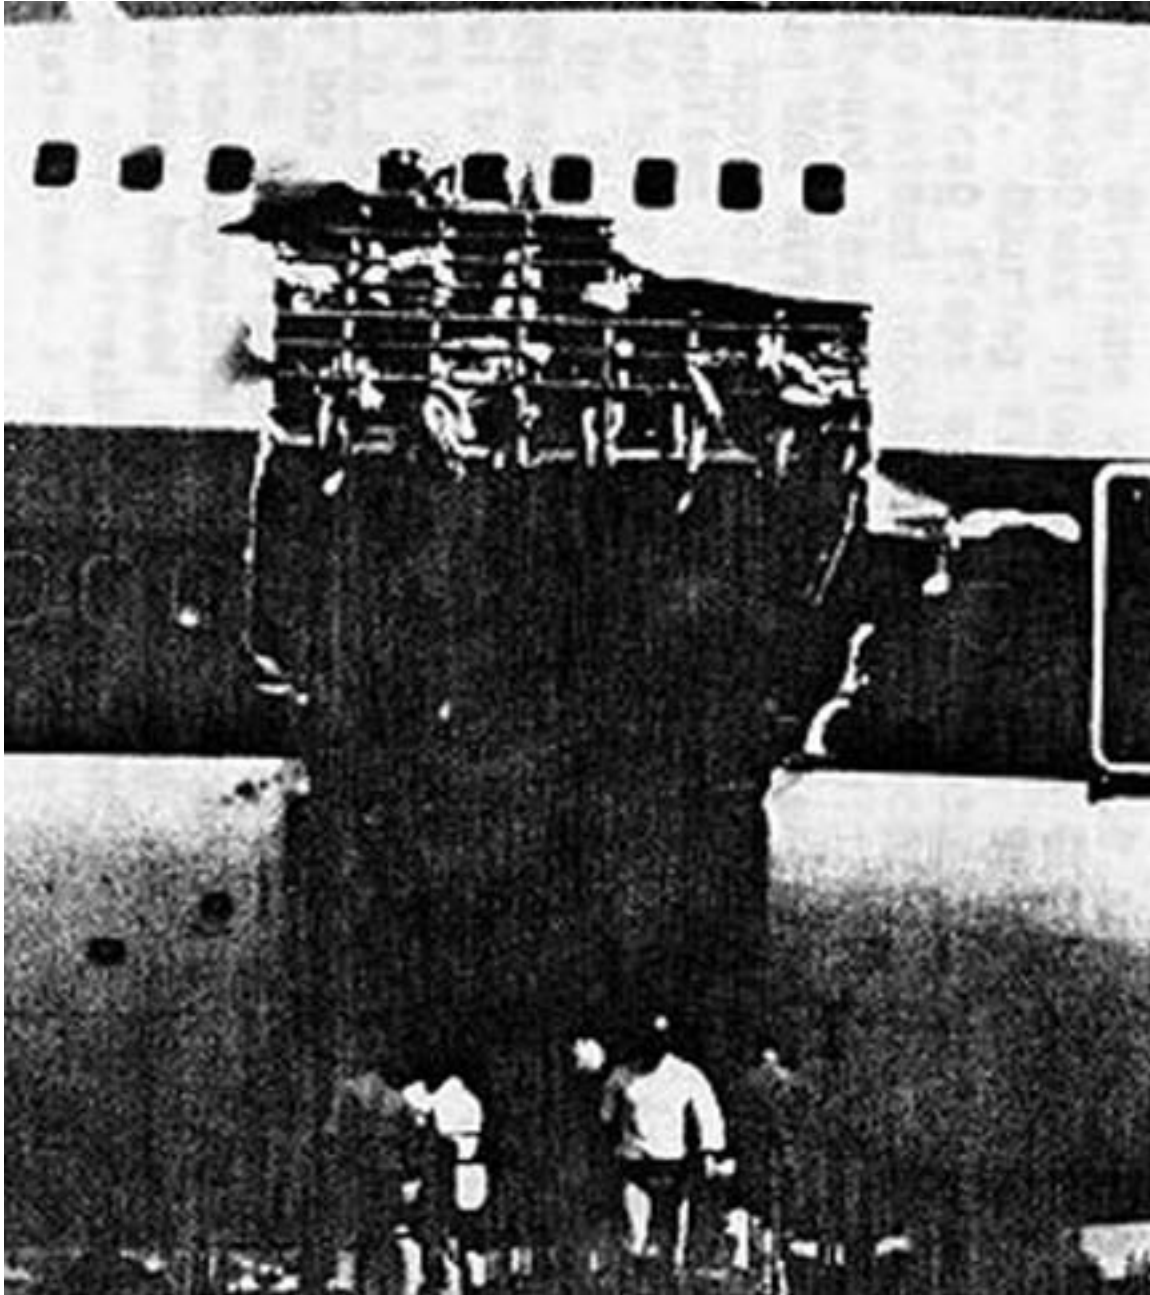
Caption for above photograph: Photo from NTSB AAR 92/02 of hole in United Airlines Flight 811 made by inadvertent opening of forward cargo door in flight.

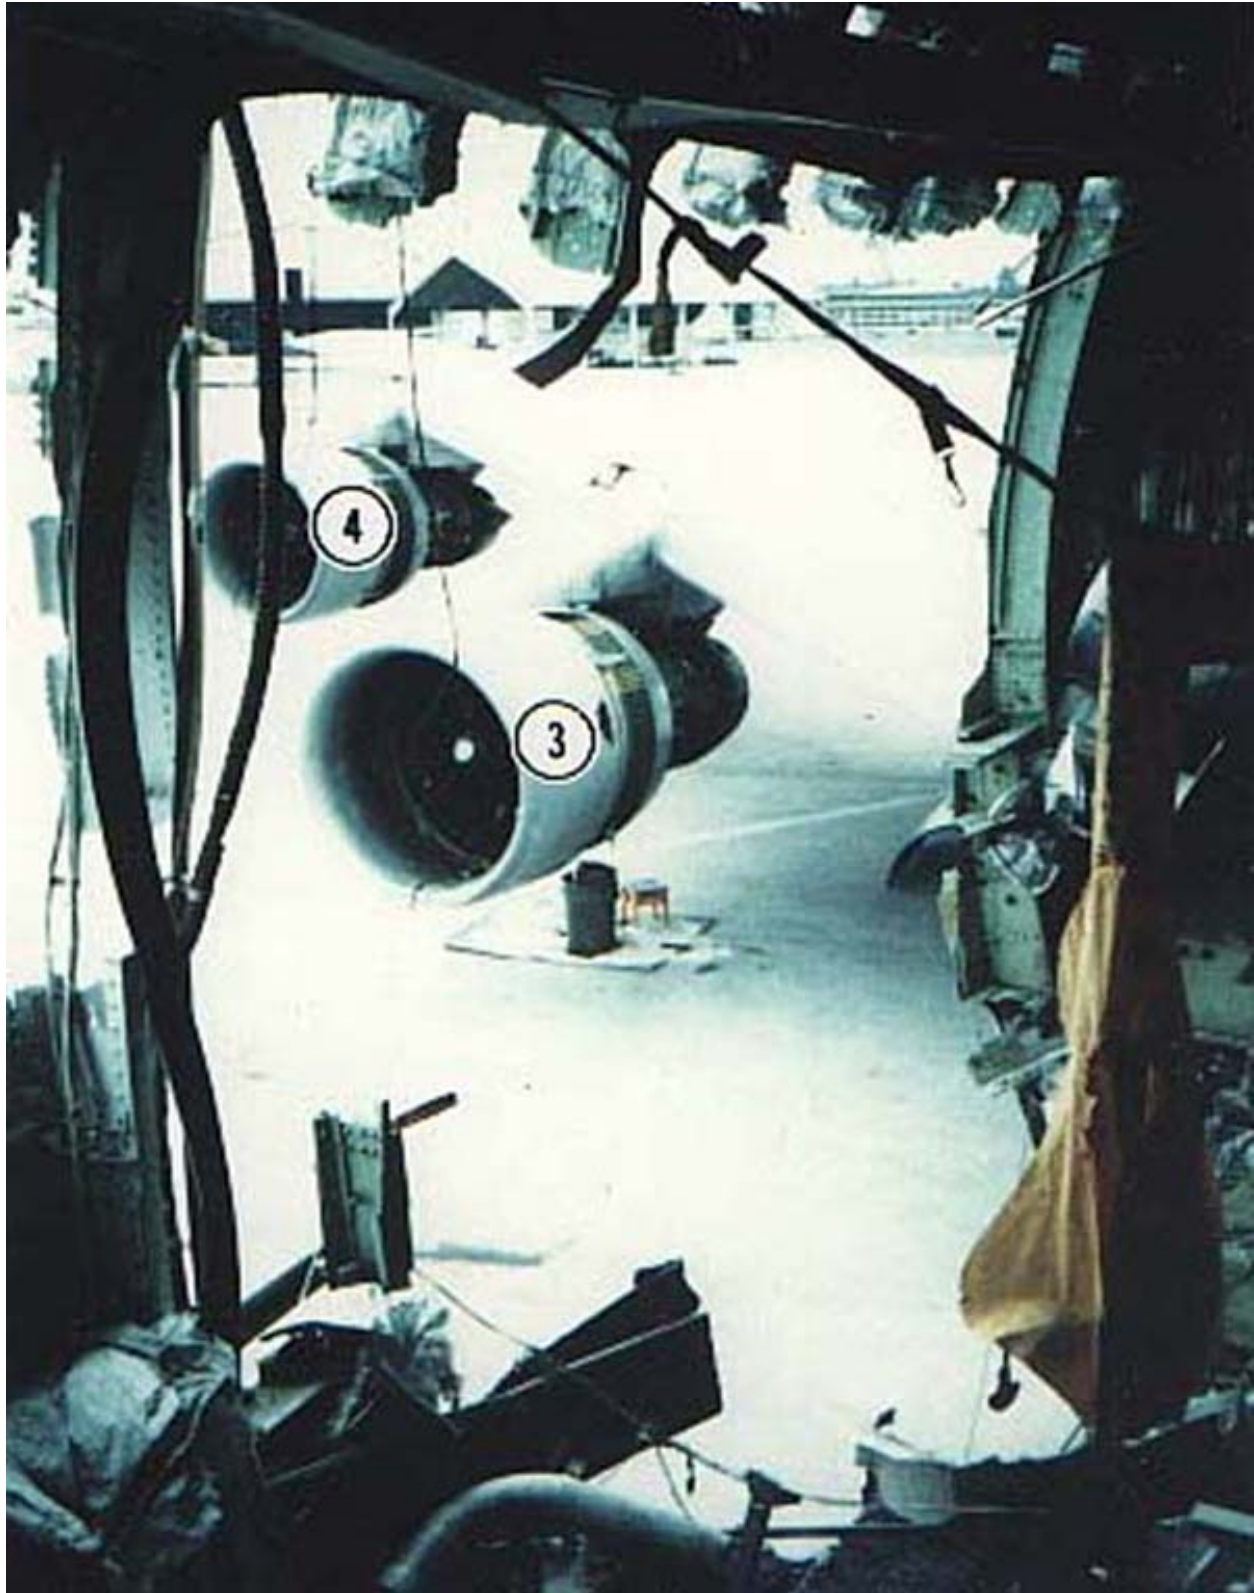
Caption for above photograph: Photo from inside United Airlines Flight 811 showing the hole caused by by inadvertent opening of forward cargo door in flight revealing engine numbers three and four which received the ejected foreign objects and caused the fire and internal engine damage.

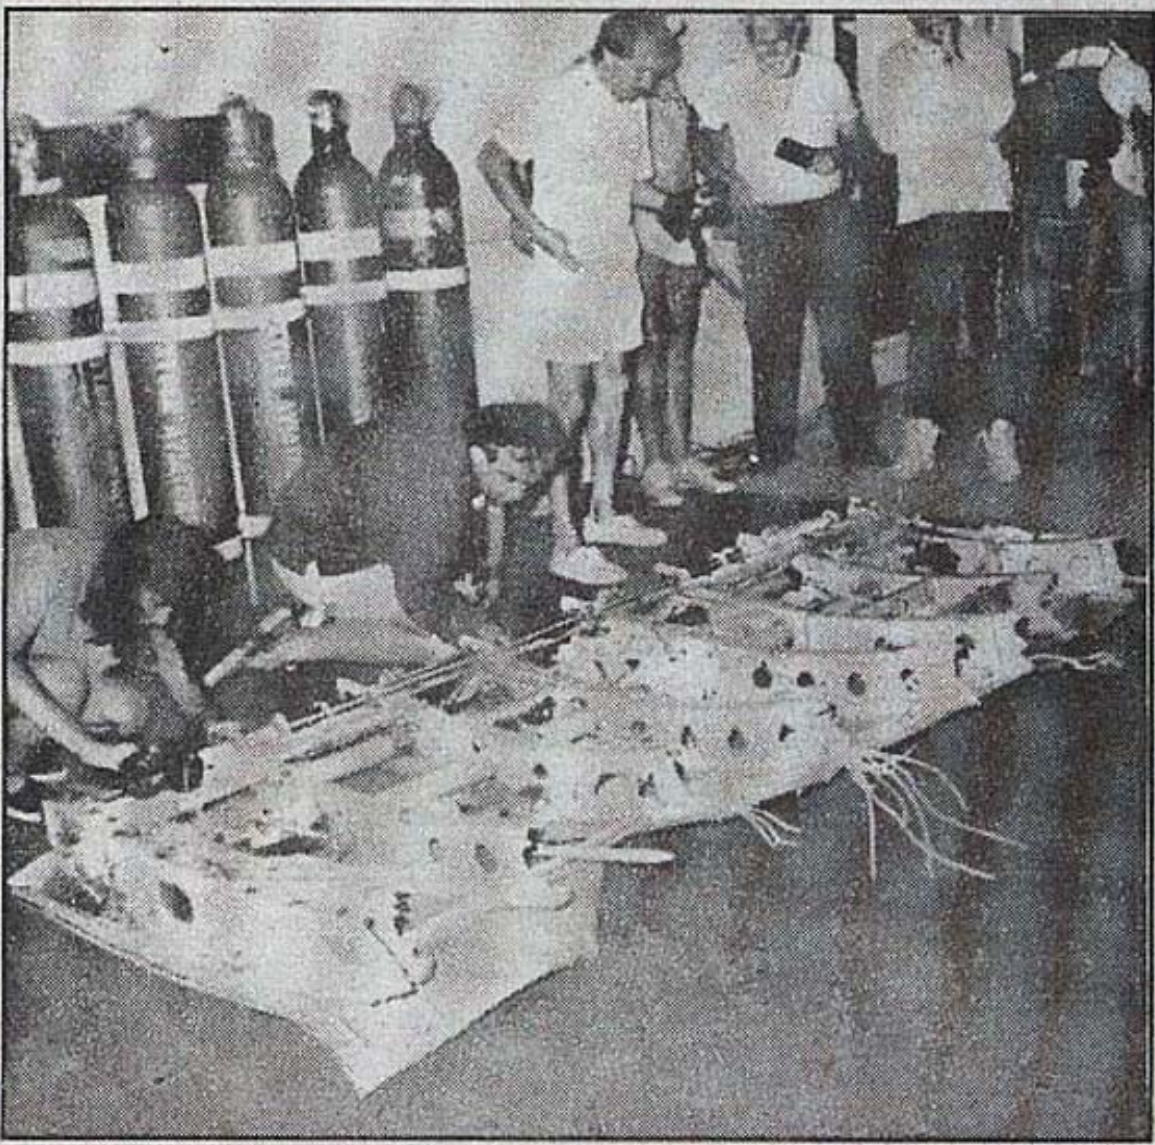
The bottom half of the cargo door from United Flight 811 is examined on board a Navy contract support ship after it was retrieved from a depth of nearly three miles. The crew of the mini-sub Sea Cliff hopes to recover the top half this weekend. See story on Page A3.

Caption for above photograph: Photo of newspaper article and photograph showing the lower half of retrieved forward cargo door, loose wiring, the longitudinal split at midspan latches, and the peeled away skin from the aft midspan latch.

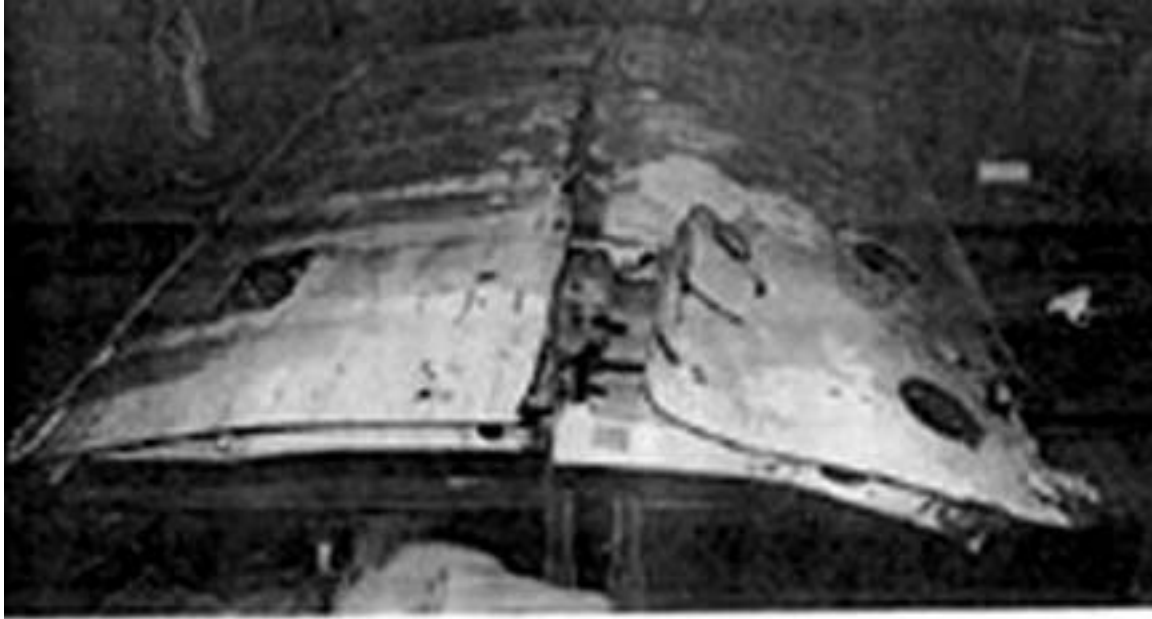
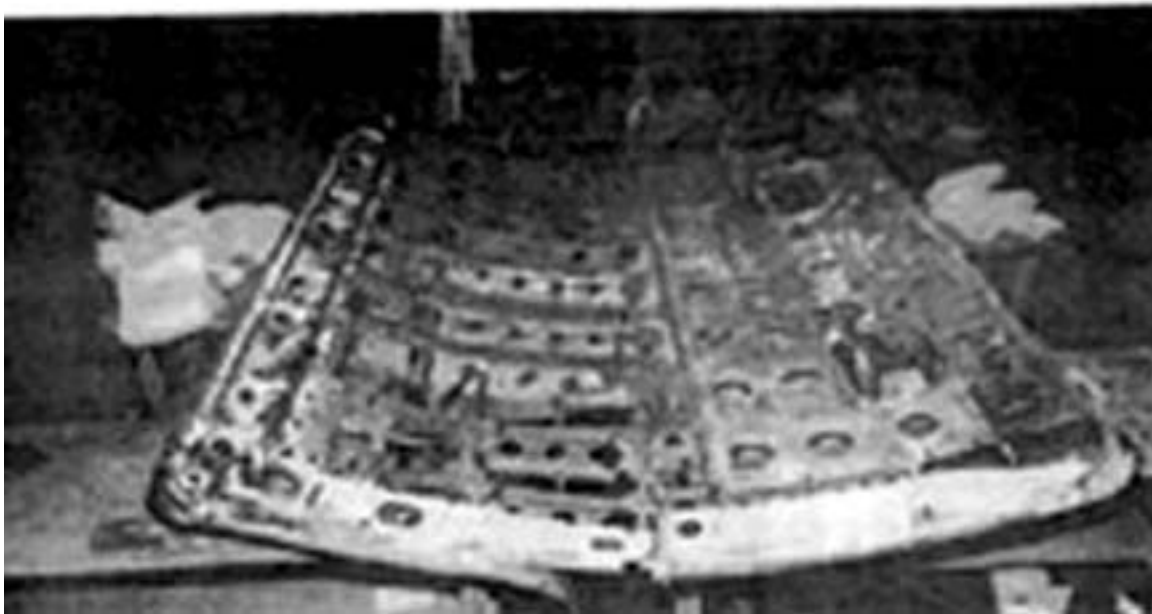
Caption for above photograph: Photo from NTSB AAR 92/02 for United Airlines Flight 811 showing both halves of the retrieved door, the longitudinal split at midspan latches, and the peeled away skin from the aft midspan latch.

'The National Transportation Safety Board determines that the probable cause of this accident was the sudden opening of the forward lower lobe cargo door in flight and the subsequent explosive decompression. The door opening was attributed to a faulty switch or wiring in the door control system which permitted electrical actuation of the door latches toward the unlatched position after initial door closure and before takeoff. Contributing to the cause of the accident was a deficiency in the design of the cargo door locking mechanisms, which made them susceptible to deformation, allowing the door to become unlatched after being properly latched and locked.'

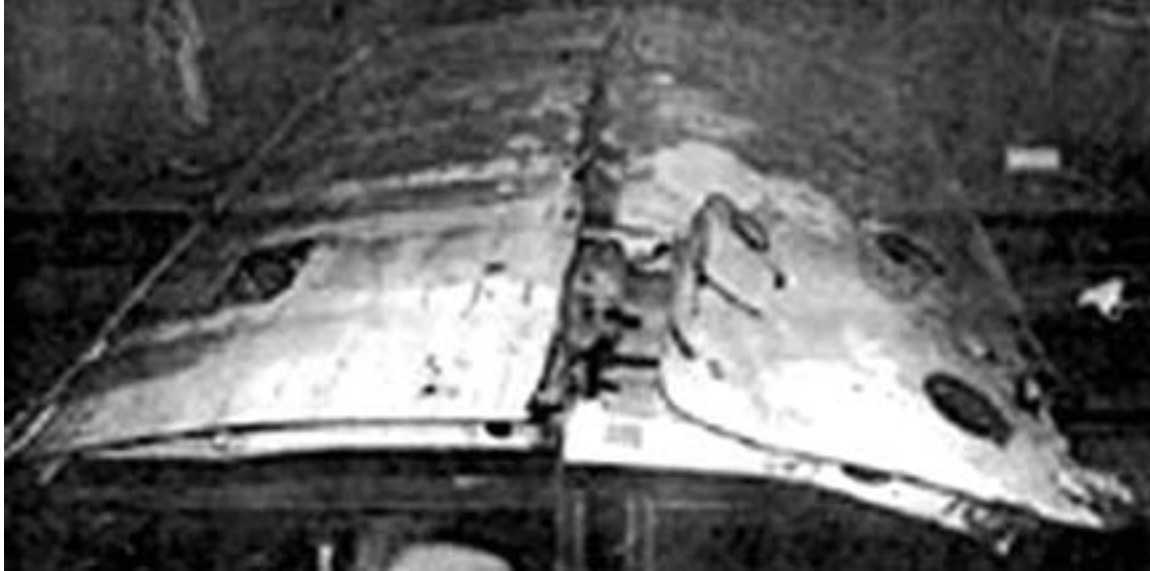
Caption for above photograph: Photo from NTSB AAR 92/02 for United Airlines Flight 811 showing bottom half of the retrieved door, the longitudinal split at midspan latches, and the peeled away skin from the aft midspan latch.

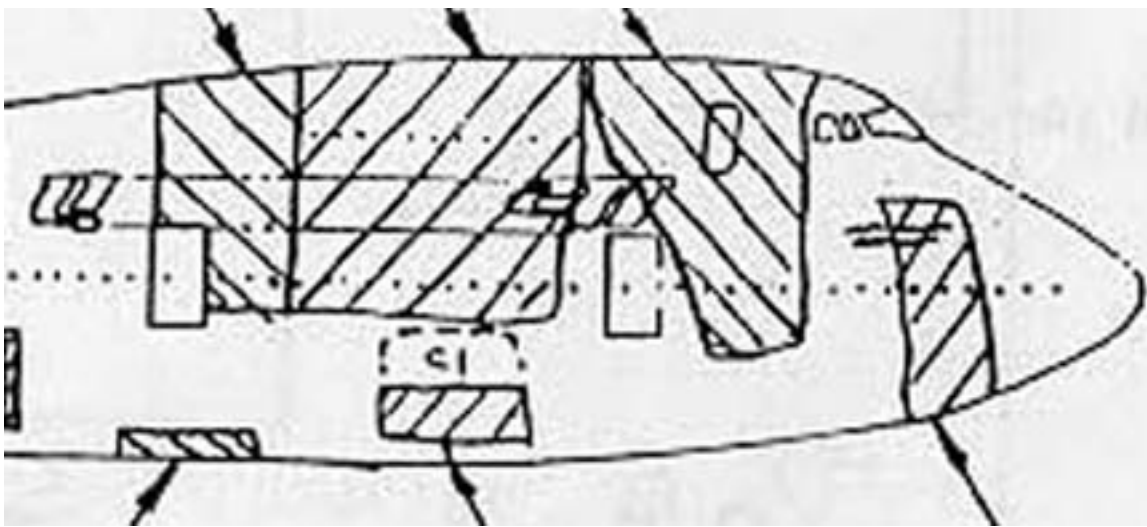
Caption for above drawing: Reconstruction drawing from the Kirpal Report and the CASB report on Air India Flight 182 showing the longitudinal split of the forward cargo door and the vertical tearing of the skin above the door.

"2.11.4.6 All cargo doors were found intact and attached to the fuselage structure except for the forward cargo door which had some fuselage and cargo floor attached. This door, located on the forward right side of the aircraft, was broken horizontally about one-quarter of the distance above the lower frame. The damage to the door and the fuselage skin near the door appeared to have been caused by an outward force. The fractured surface of the cargo door appeared to have been badly frayed."

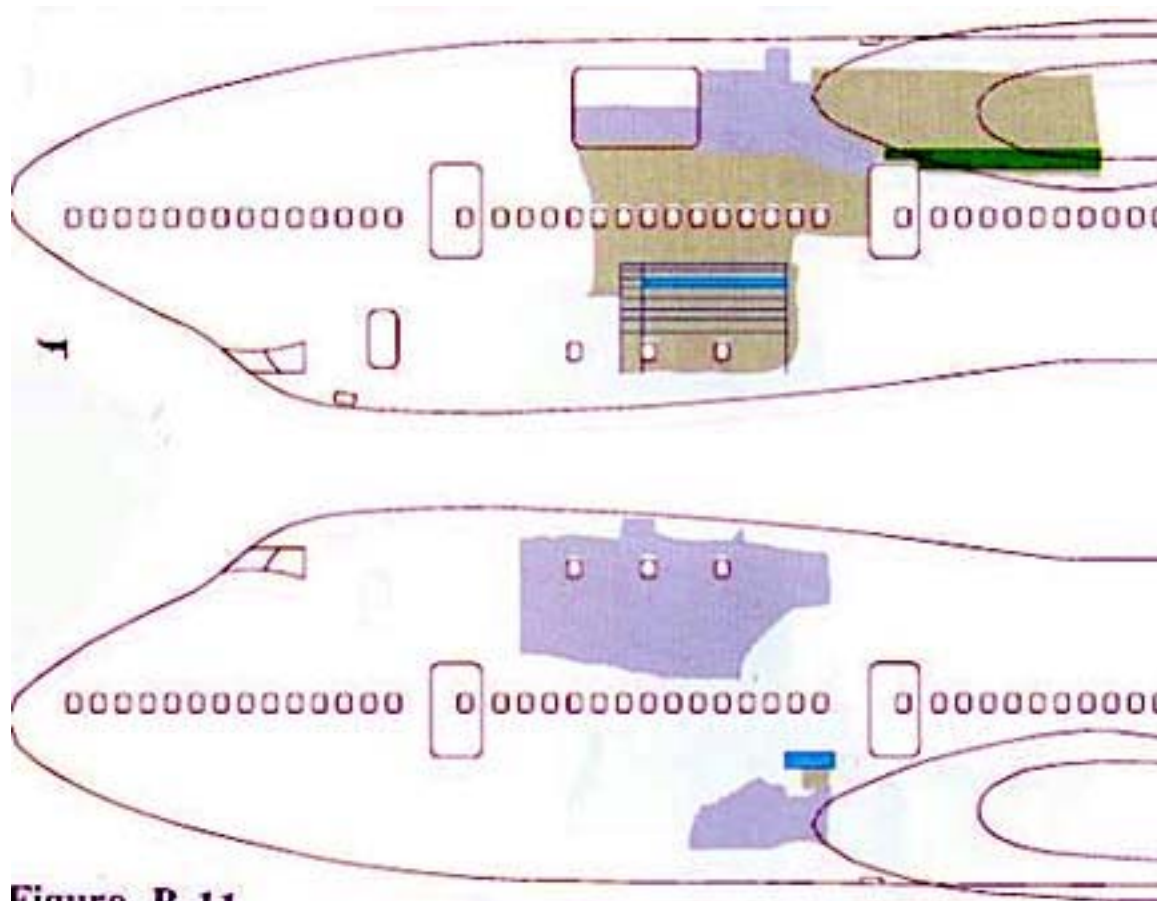
**Figure B-11**

Caption for above photograph: Figure B11 from AAIB 2/90 for Pan Am Flight 103 showing initial event time fuselage destruction with small 'bomb' hole rectangle and huge rectangular destruction around forward cargo door.

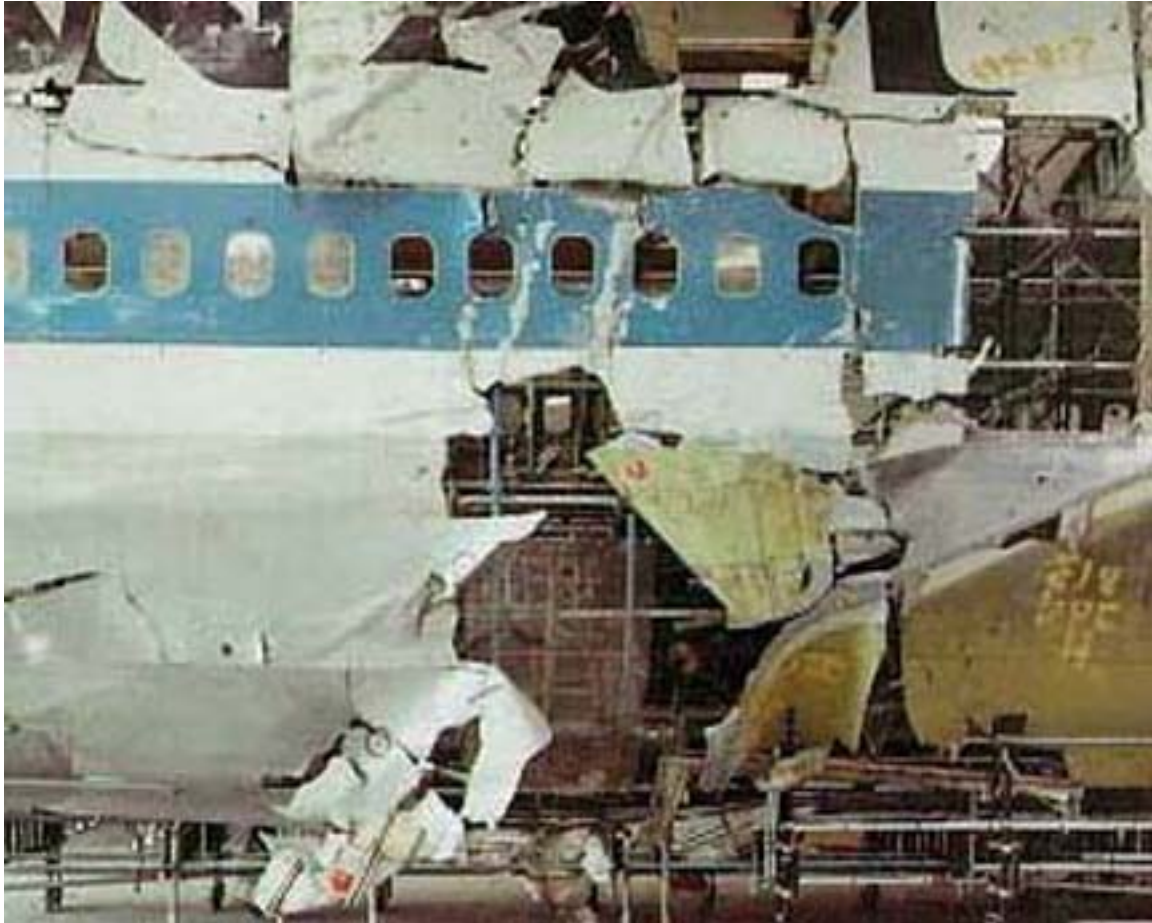
Caption for above photograph: Port side of Pan Am Flight 103 forward of the wing showing the small 'bomb' hole and relatively smooth and intact fuselage skin around it.

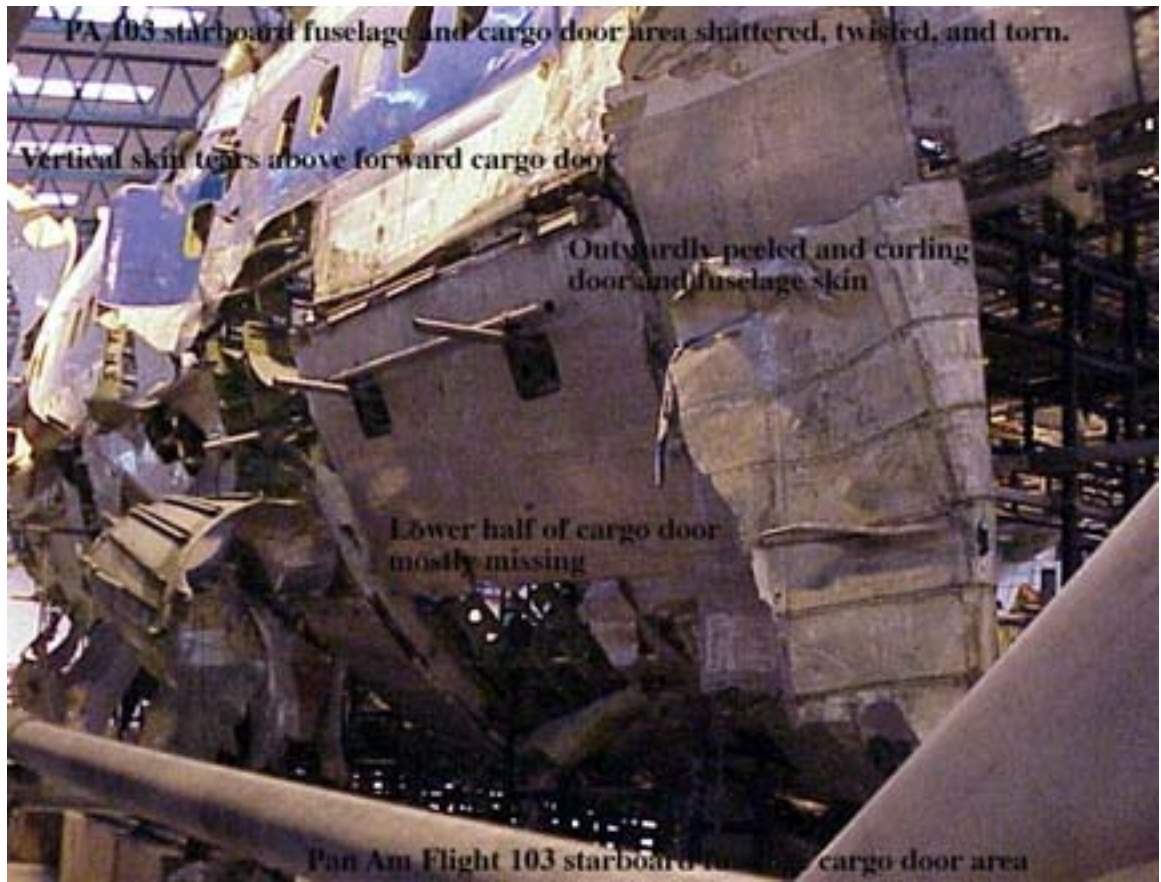
Caption for above photograph: Photograph from AAIB showing Pan Am Flight 103 forward cargo door area revealing the vertical torn skin above door, peeled back skin from the aft midspan latch, generally shattered area, and mostly missing lower half of door which includes the manual locking handle and the eight bottom latches.

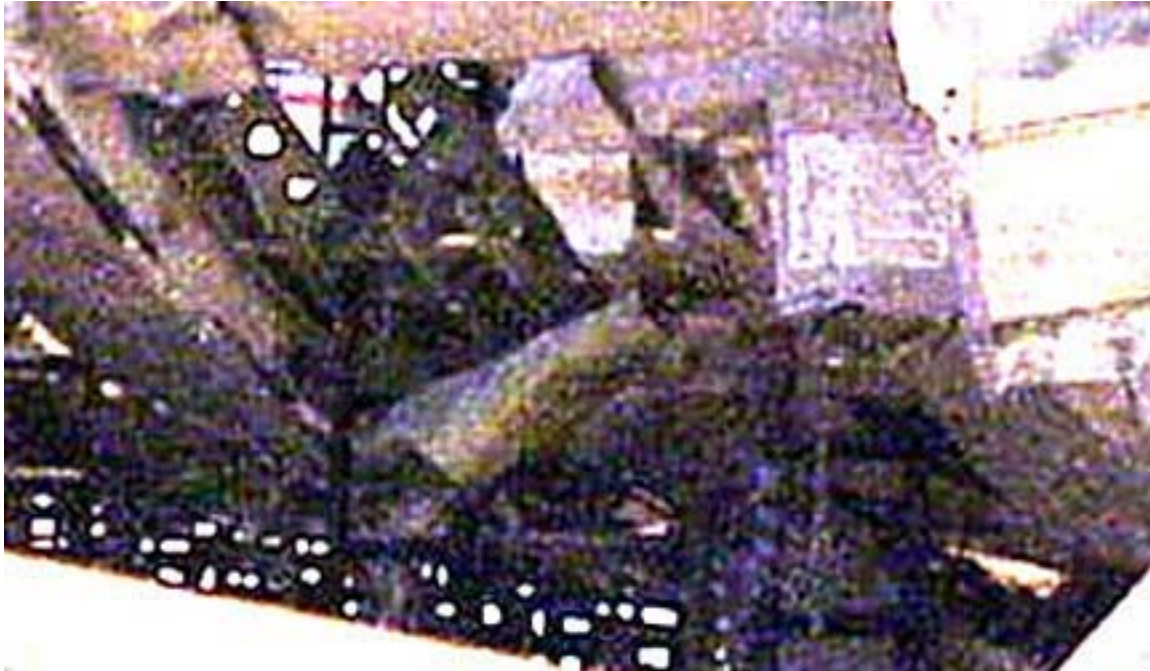
Caption for above photograph: Closeup of the peeled back skin from the aft midspan latch of the forward cargo door of Pan Am Flight 103.

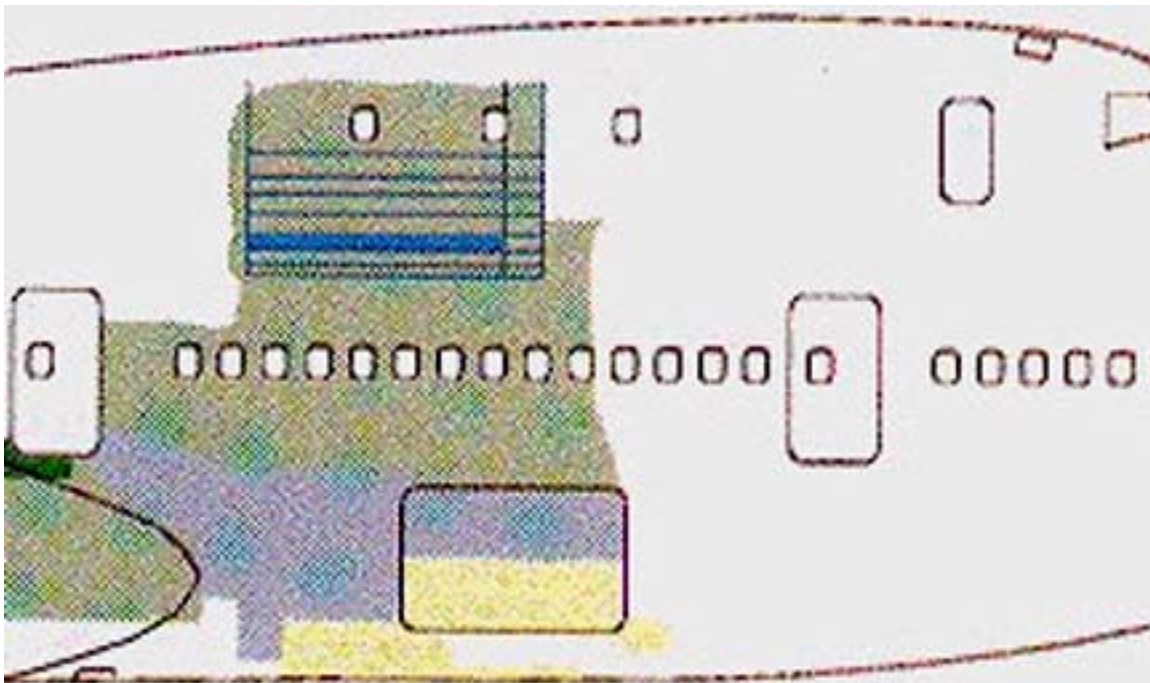
Caption for above drawing: Reconstruction drawing from the AAIB 2/90 report on Pan Am Flight 103 showing the large area of torn off skin around the forward cargo door, the longitudinal split of the door, and the vertical tearing of the skin above the door.

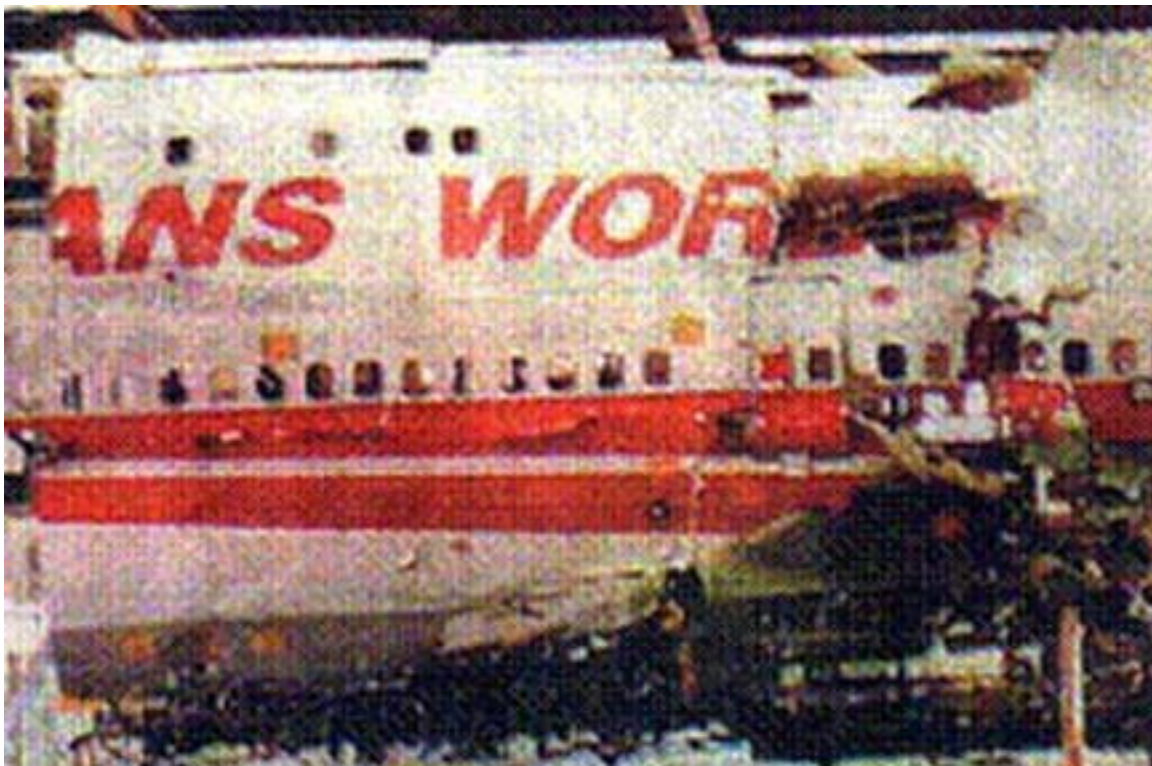
Caption for above photograph: Photograph of the port side of Trans World Airlines Flight 800 showing the relative undamaged skin forward of the wing.

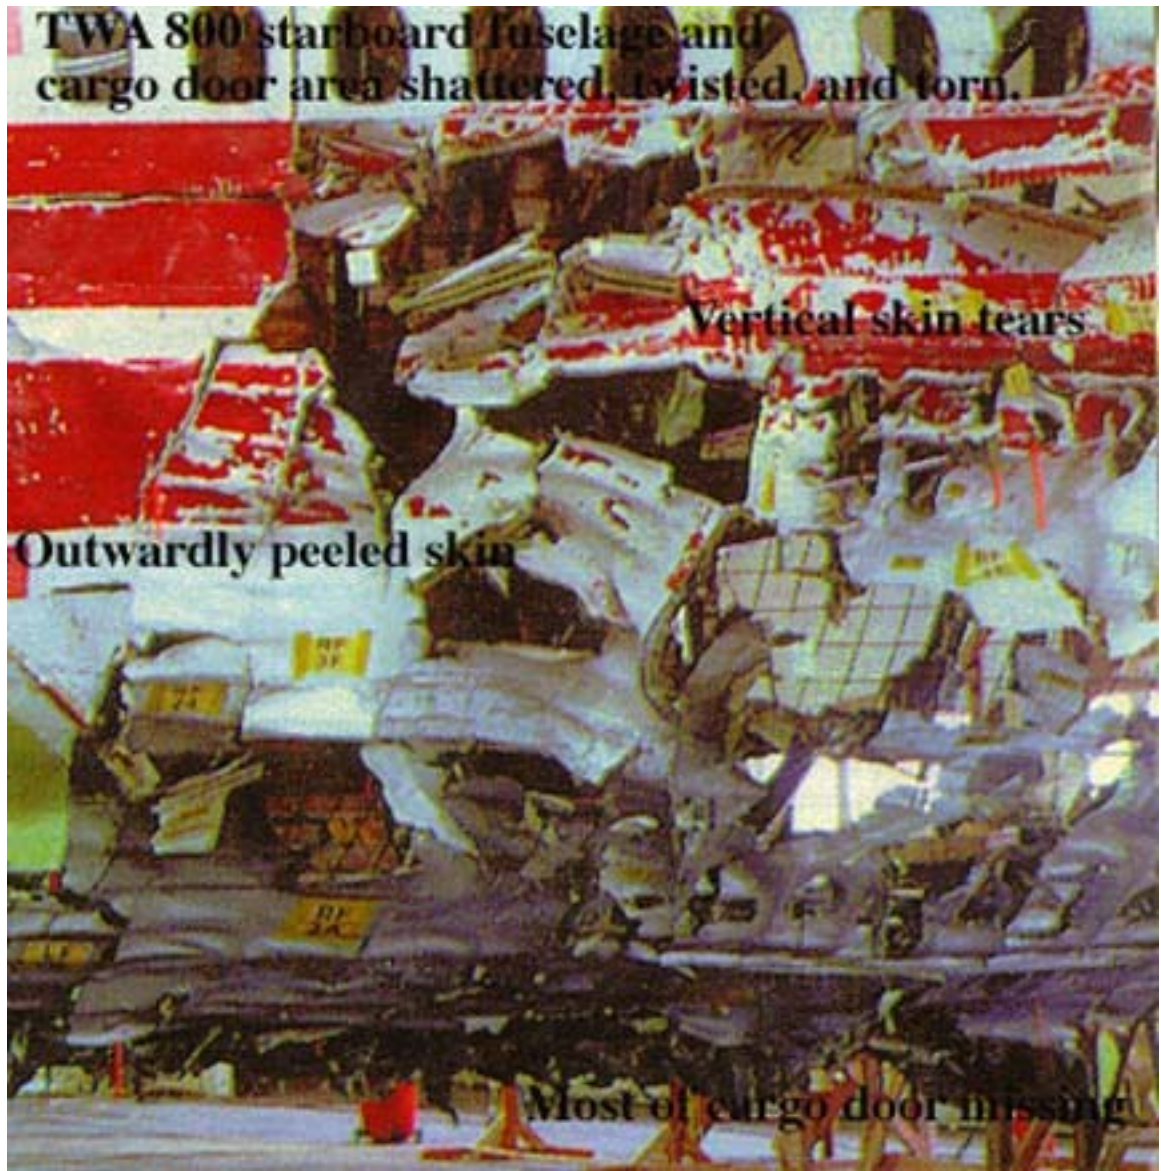
Caption for above photograph: Shattered starboard side around forward cargo door of Trans World Airlines Flight 800 revealing outwardly and petaled shaped skin around aft midspan latch.

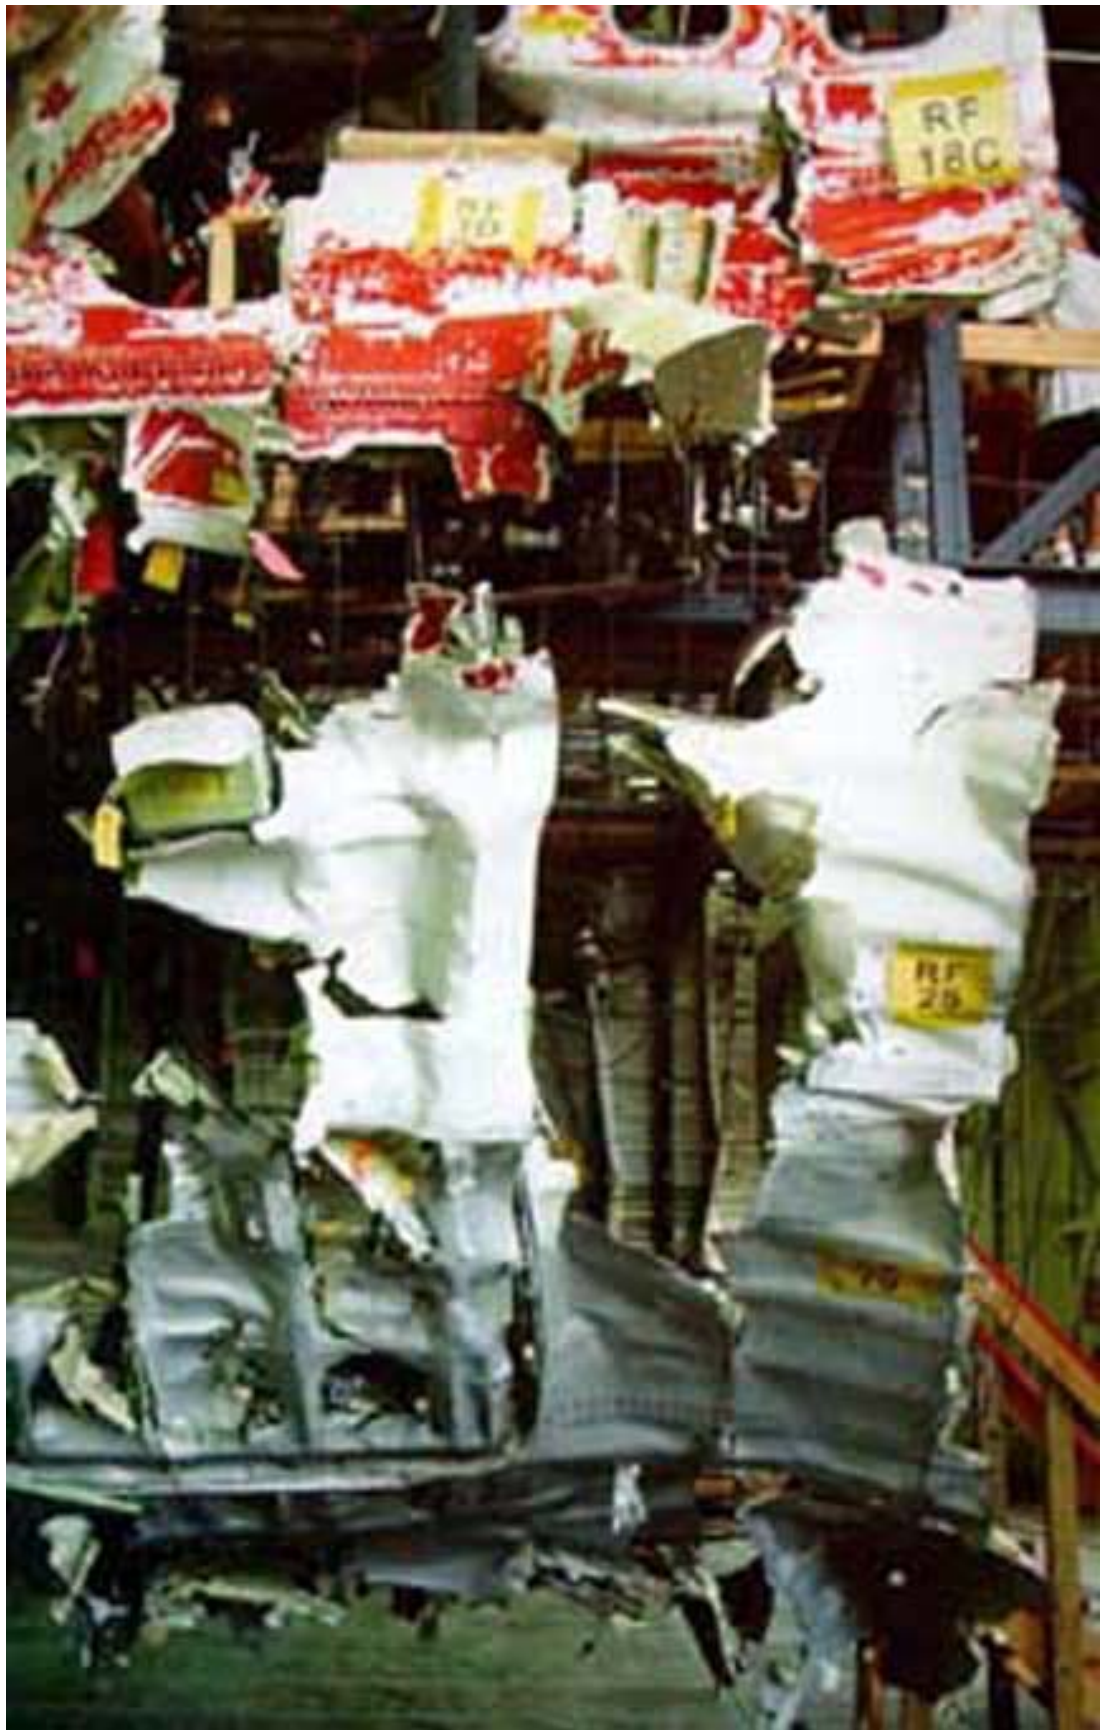
Caption for above photograph: Photograph showing outwardly and petaled shaped skin around forward midspan latch.

3. Docket Number SA-516, Exhibit No. 15C, Report Number 97-82, Section 41/42 Joint, Forward Cargo Door, "Examination of the lower lobe forward cargo door showed that all eight of the door latching cams remain attached (along with pieces of the door itself) to the pins along the lower door sill."

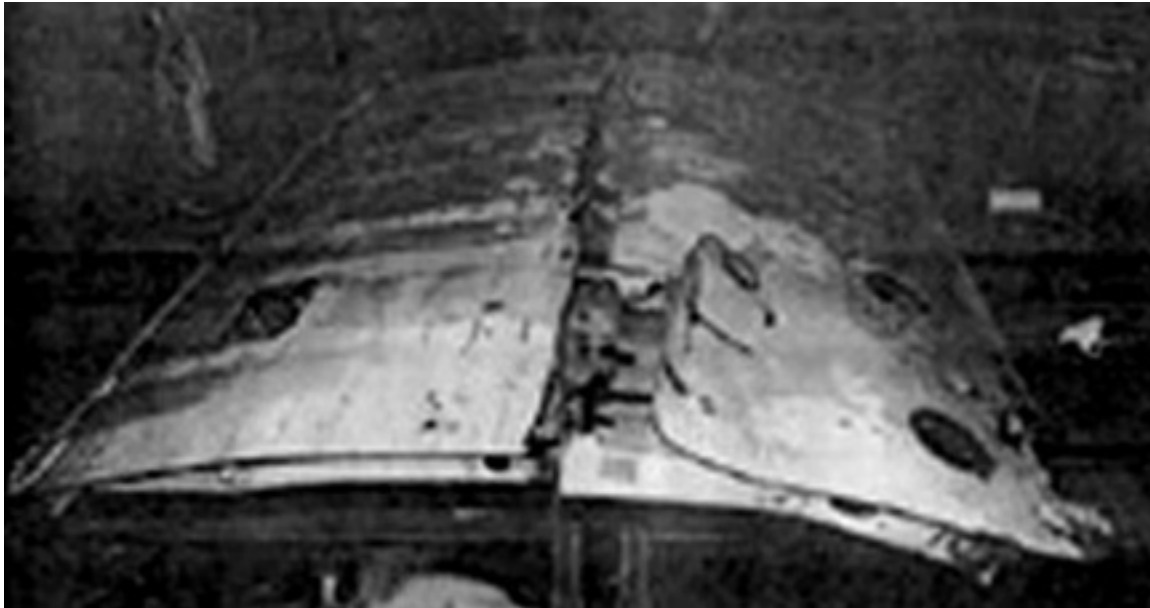
Caption for above photograph: Photo from NTSB AAR 92/02 for United Airlines Flight 811 showing bottom half of the retrieved door, the longitudinal split at midspan latches, and the peeled away skin from the aft midspan latch.

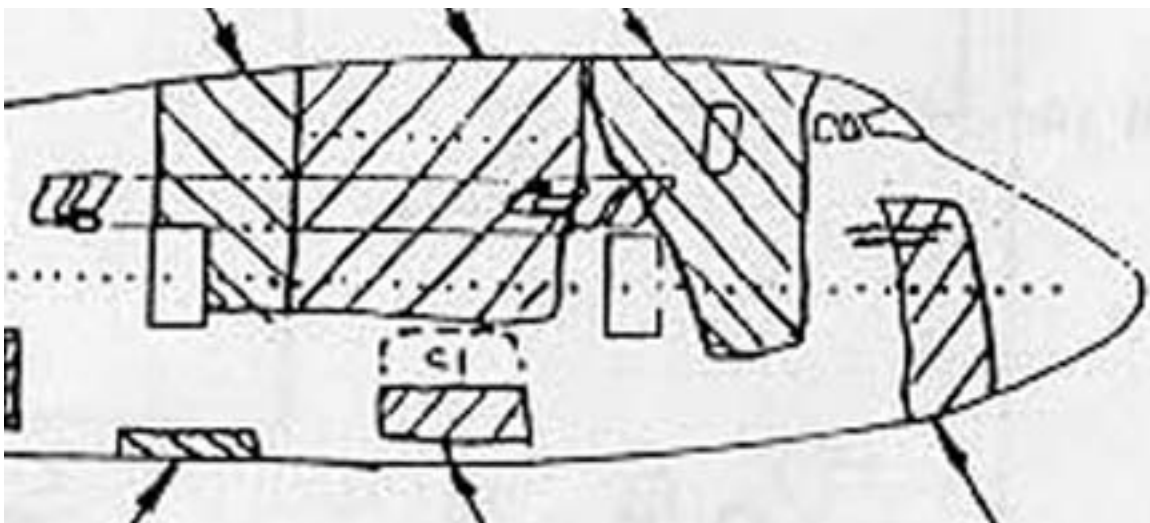
Caption for above drawing:  
Reconstruction drawing from the Kirpal Report and the CASB report on Air India Flight 182 showing the longitudinal split of the forward cargo door and the vertical tearing of the skin above the door.

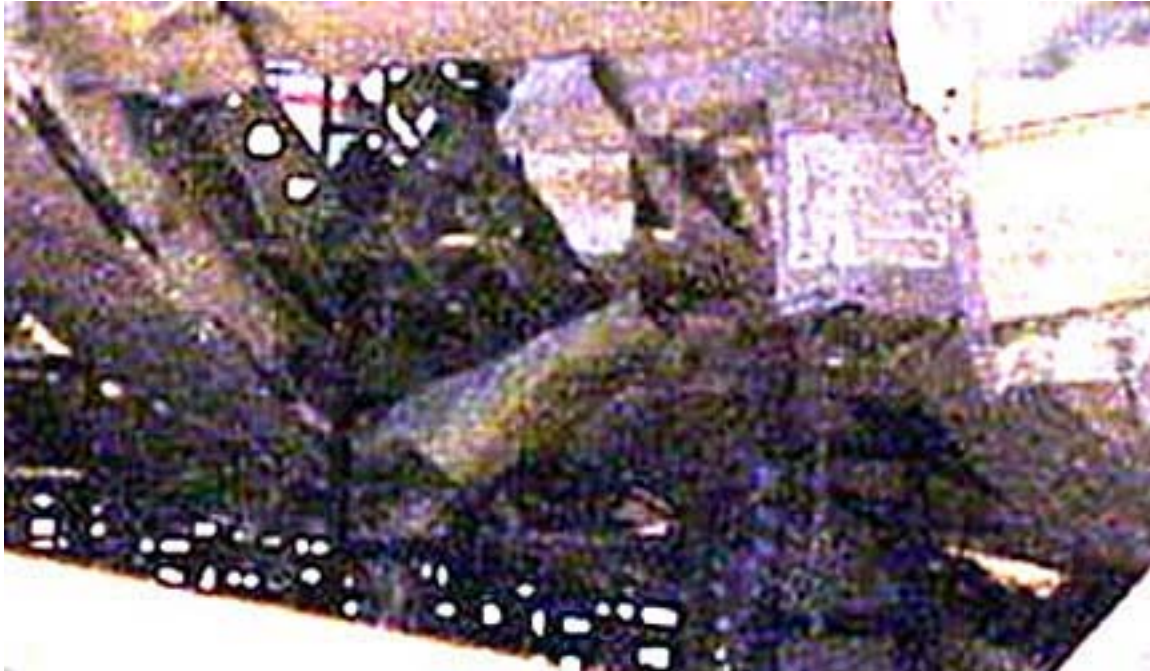
Caption for above photograph: Closeup of the peeled back skin from the aft midspan latch PA 103

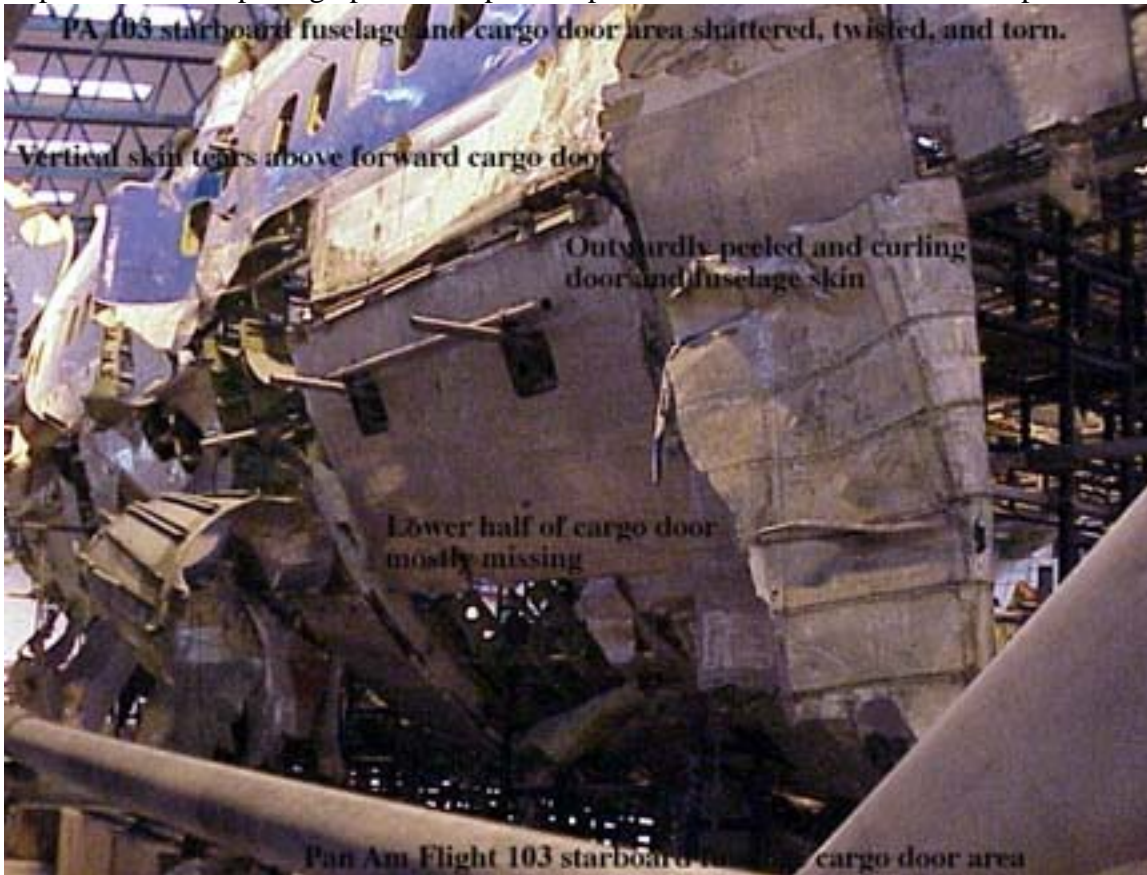
Caption for above photograph: Photograph from AAIB showing Pan Am Flight 103 forward cargo door area revealing the vertical torn skin above door, peeled back skin from the aft midspan latch, generally shattered area, and mostly missing lower half of door which includes the manual locking handle and the eight bottom latches.
