Shorted wiring/forward cargo door rupture/explosive decompression/inflight breakup explanation described in pictures, text, and drawings for United Airlines Flight 811, Pan Am Flight 103, Air India Flight 182, and Trans World Airlines Flight 800.

John Barry Smith 22 March 2002

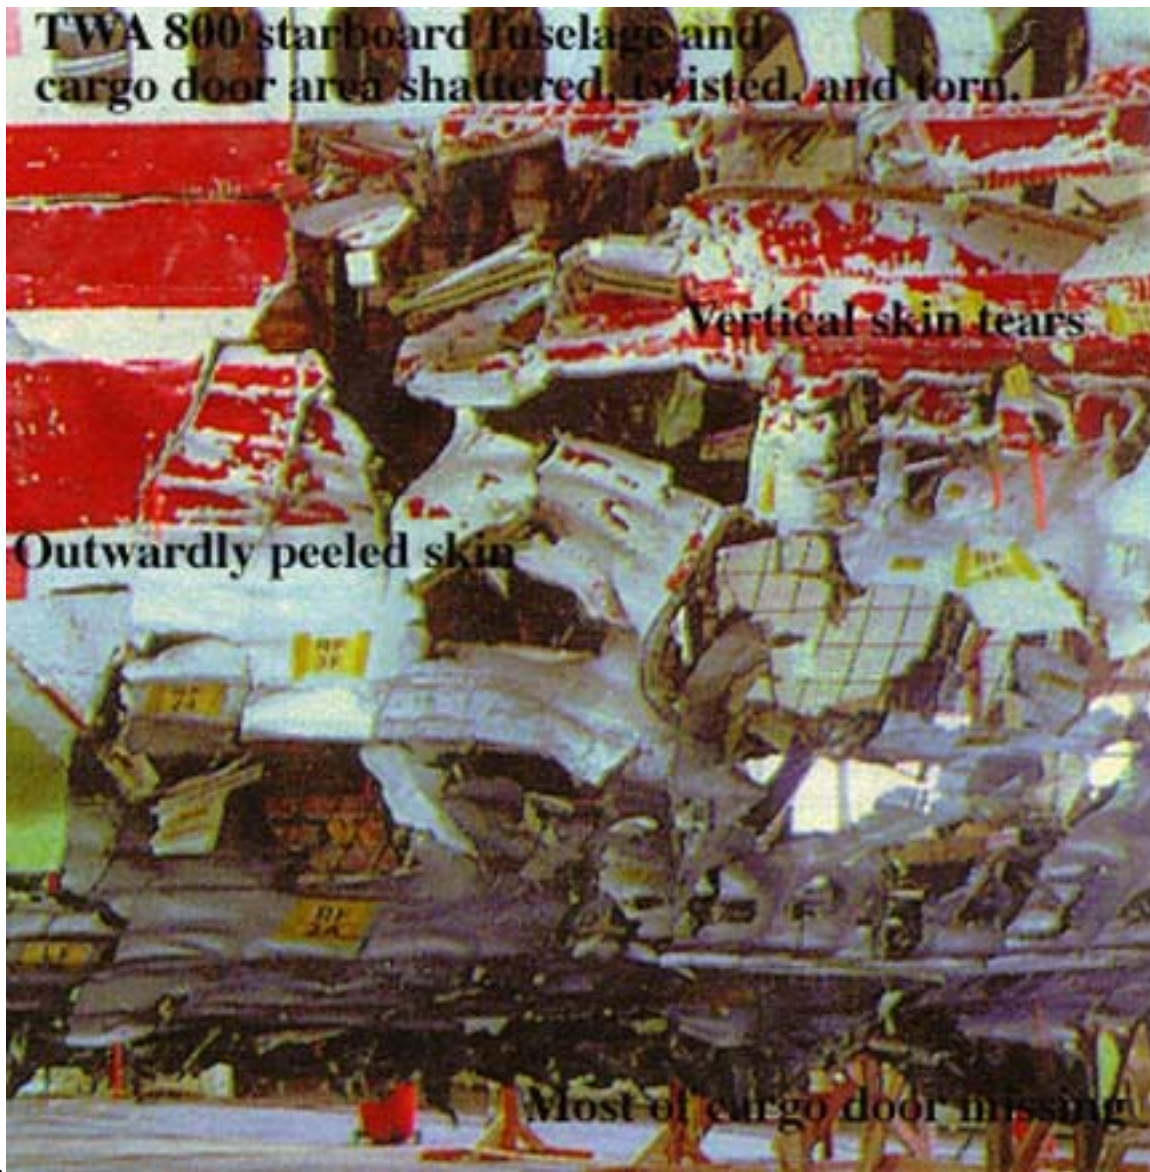
Caption for above photograph: Shattered starboard side around forward cargo door of Trans World Airlines Flight 800 revealing outwardly and petaled shaped skin around aft midspan latch.
