AIRCRAFT OCCURRENCE INVESTIGATION REPORT

Air India Flight 182, "Kanishka"
Boeing 747-237B, VT-EFO

by: John H. Garstang

16 March 2001

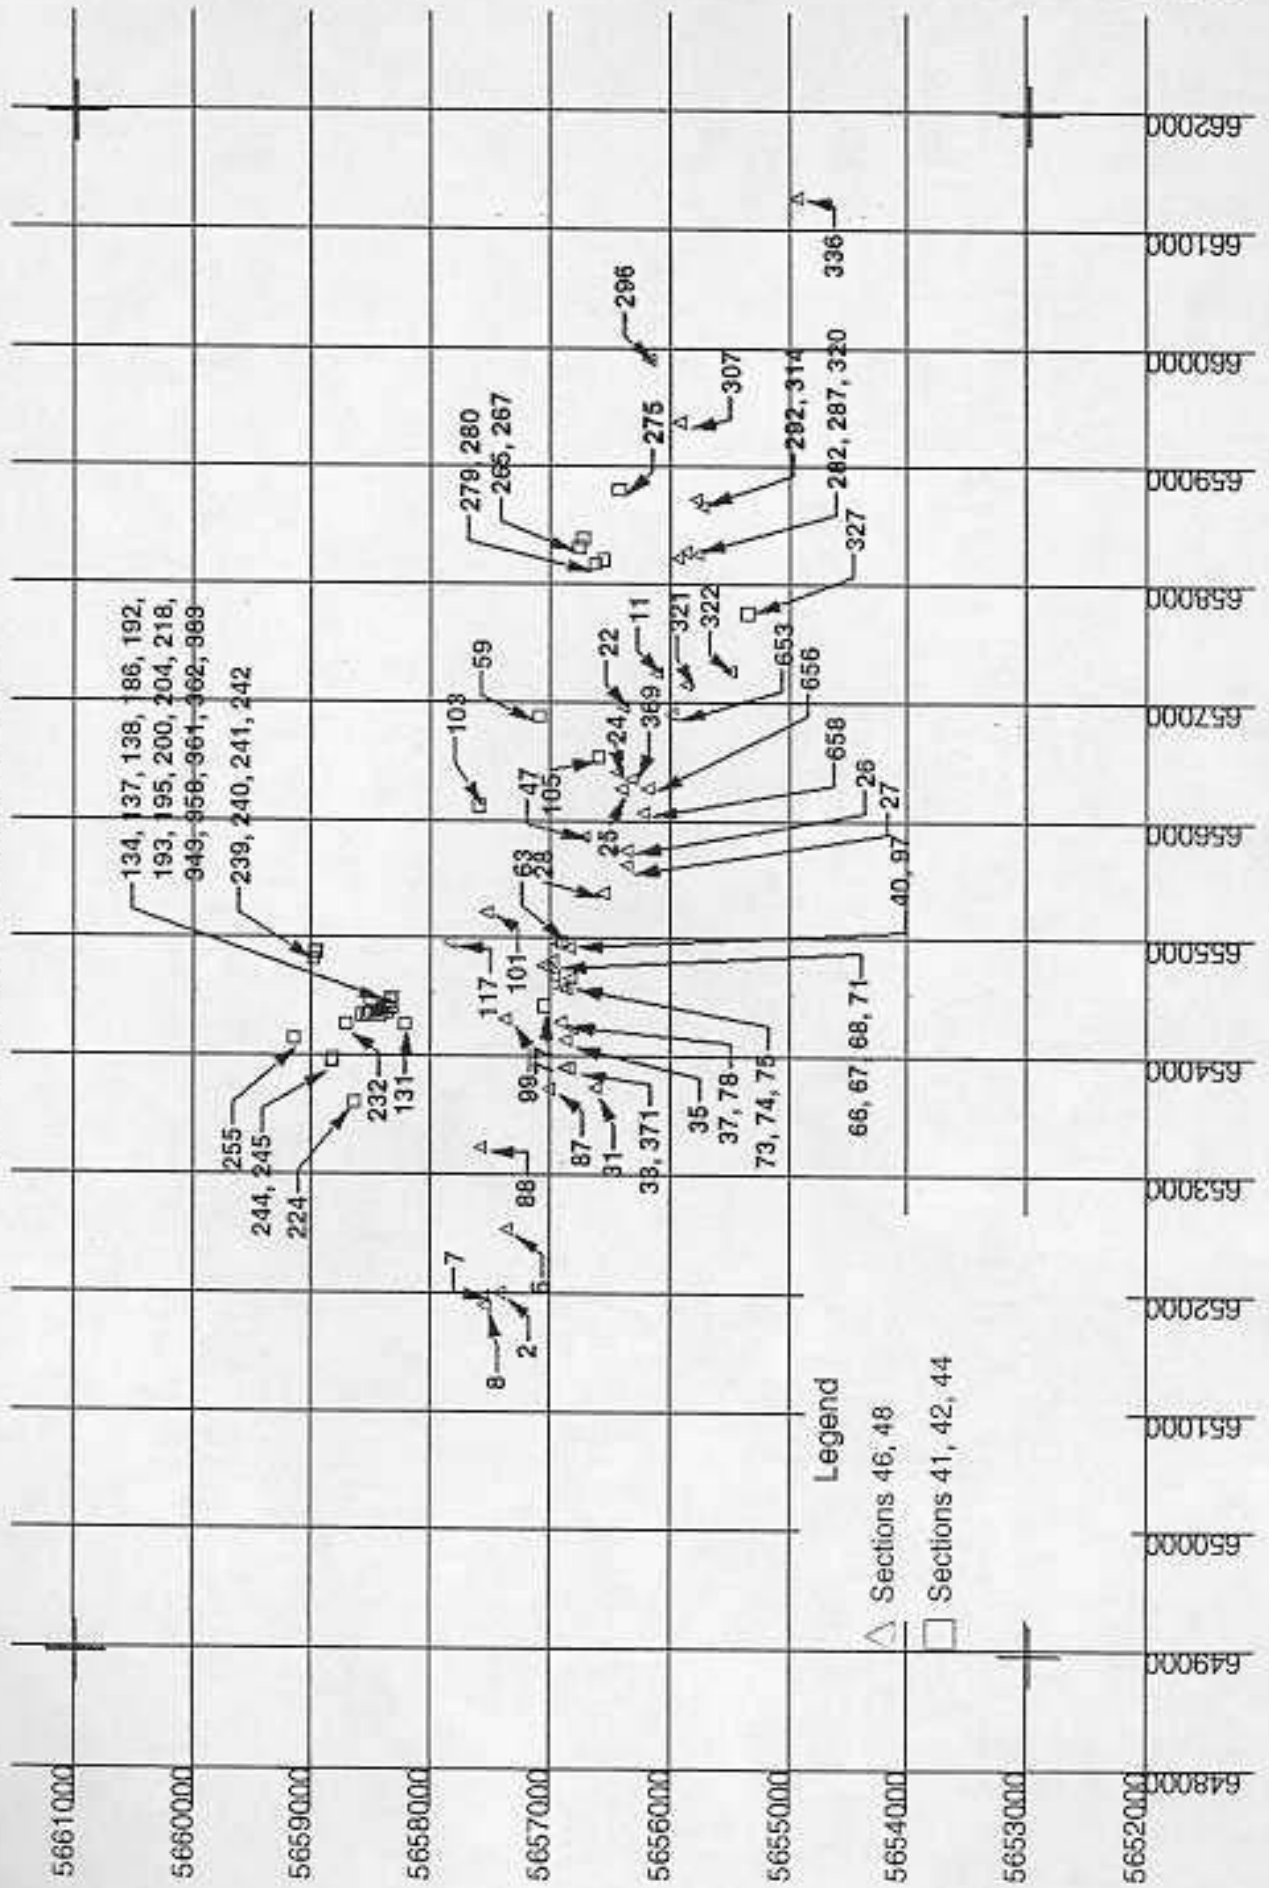
Plot of Targets: Northern & Southern Wreckage Trails
 Universal Transverse Mercator Grid

44). This will be referred to as the Northern trail (coloured red). Since this trail was the second trail encountered off the aircraft track, the trajectory analysis indicates that this group of items separated from the aircraft as a second, separate event, after the first. In other words, the analysis indicates that the aircraft broke up in-flight in two major stages (refer to Appendices "H" and "I"). Parts comprising the Northern wreckage trail were found to be forward of the STA 1480 break, and parts comprising the Southern wreckage trail were aft of this break.

trail (Sections 41, 42, and 44- forward half of the aircraft fuselage). As previously noted in the structural breakup analysis section of this report (refer to Section 6.0), the forward half of the aircraft fuselage had fractured such that it tended to be in larger, more complete chunks, clumps, or clusters of parts. In addition, more of the interior of the forward half was found intermixed or contained within exterior pieces of the skin as exemplified by targets "192", "218", and "137". This was in contrast to the rear half of the aircraft where the interior tended to be stripped away. From a trajectory analysis perspective, these findings are consistent with the structure of the rear half of the aircraft being much more extensively broken up at altitude and scattered, than the forward half of the fuselage.

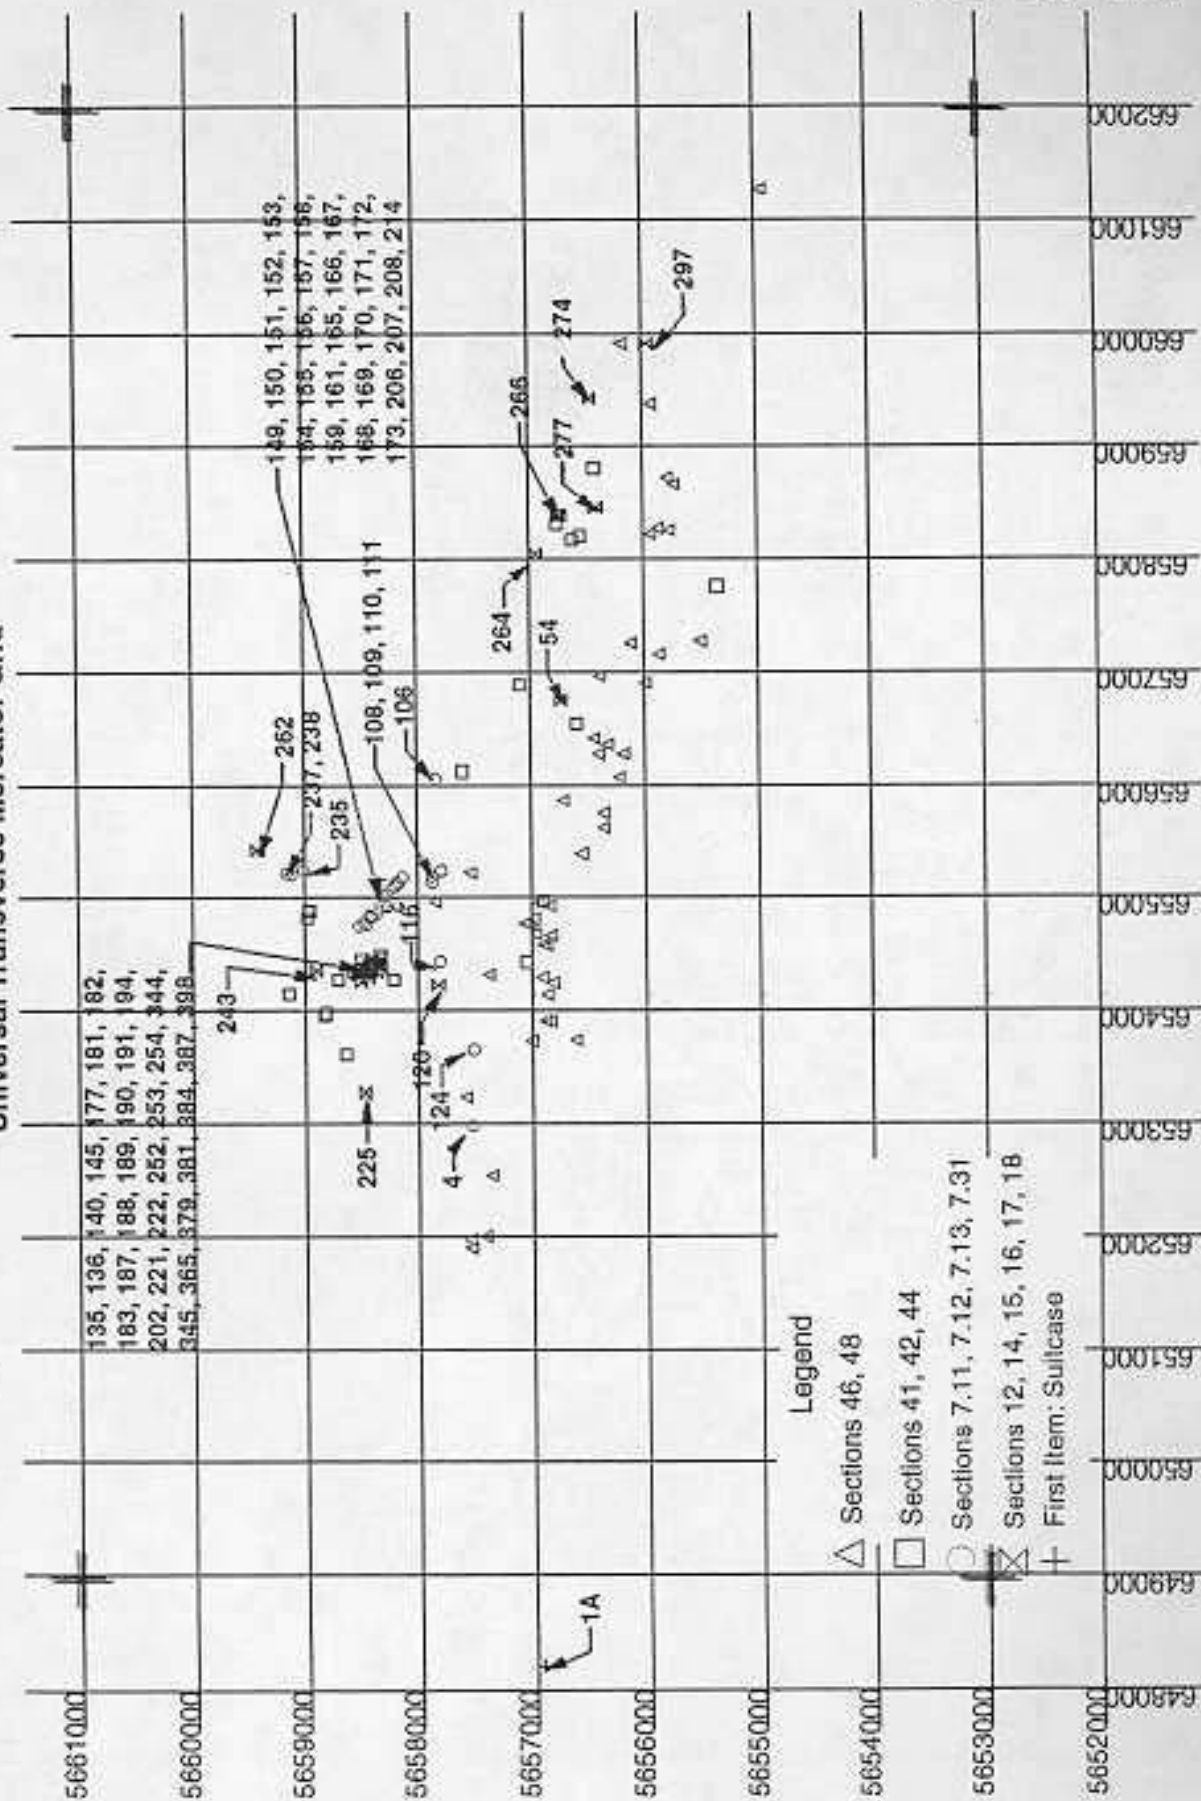
Plot of Targets: Northern & Southern Wreckage Trails, Engine & Wing Parts, 1st Item Found
 Universal Transverse Mercator Grid

It is significant to note that the very first item found (the most Westerly part) was a tom suitcase (target "1A!"). This suitcase was situated approximately 3 1/2 kilometres West from the Western edge of the main debris field. Since it was found so early along the flight path, it is consistent that this is one of the very first items to have separated from the aircraft. In order for this to take place it is likely that an opening in the fuselage occurred at a location where a suitcase was in proximity to the opening, such as in the vicinity of a cargo compartment or overhead locker (if an item of this type would have been allowed to be taken into the passenger compartment as carry-on luggage). In addition, some of the first items to be found at the beginning of the Southern trail were targets "8" (piece of belly skin below the aft end of the aft cargo compartment, extending to the forward end of the bulk cargo compartment), target "7" (large piece of belly skin below the aft cargo compartment) and target "2" (piece of cargo compartment floor from the aft cargo compartment). Based on the trajectory analysis, evidence indicates that the suitcase probably came from the rear of the aircraft, since the first off Southern trail of wreckage was comprised almost exclusively of pieces from the rear of the aircraft. Early breakup of the bulk cargo and aft cargo compartments was indicated by the early presence of targets "6811", "7" and "2" at the beginning of the trail.
