National Transportation Safety Board

Safety Recommendation

Overview: Incidents resulting from damage to electrical wiring

AAIB Bulletin No: 6/2004	Ref: EW/C2003/06/03	Category: 1.1
INCIDENT		
Aircraft Type and Registration:	Concorde Type 1 V102, G-BOAC	
No & Type of Engines:	4 Rolls-Royce Olympus 593 turbojets	
Year of Manufacture:	1975	
Date & Time (UTC):	13 June 2003, time unknown	
Location:	Transatlantic cruise	
Type of Flight:	Public Transport (Passenger)	
Persons on Board:	Crew - 9	Passengers - 98
Injuries:	Crew - None	Passengers - None
Nature of Damage:	Fire damage in under wing area	
Commander's Licence:	Airline Transport Pilot's Licence	
Commander's Age:	55 years	
Commander's Flying Experience:	17,000 hours (of which 2,200 were on type)	
	Last 90 days - 60 hours	
	Last 28 days - 20 hours	
Information Source:	AAIB Field Investigation

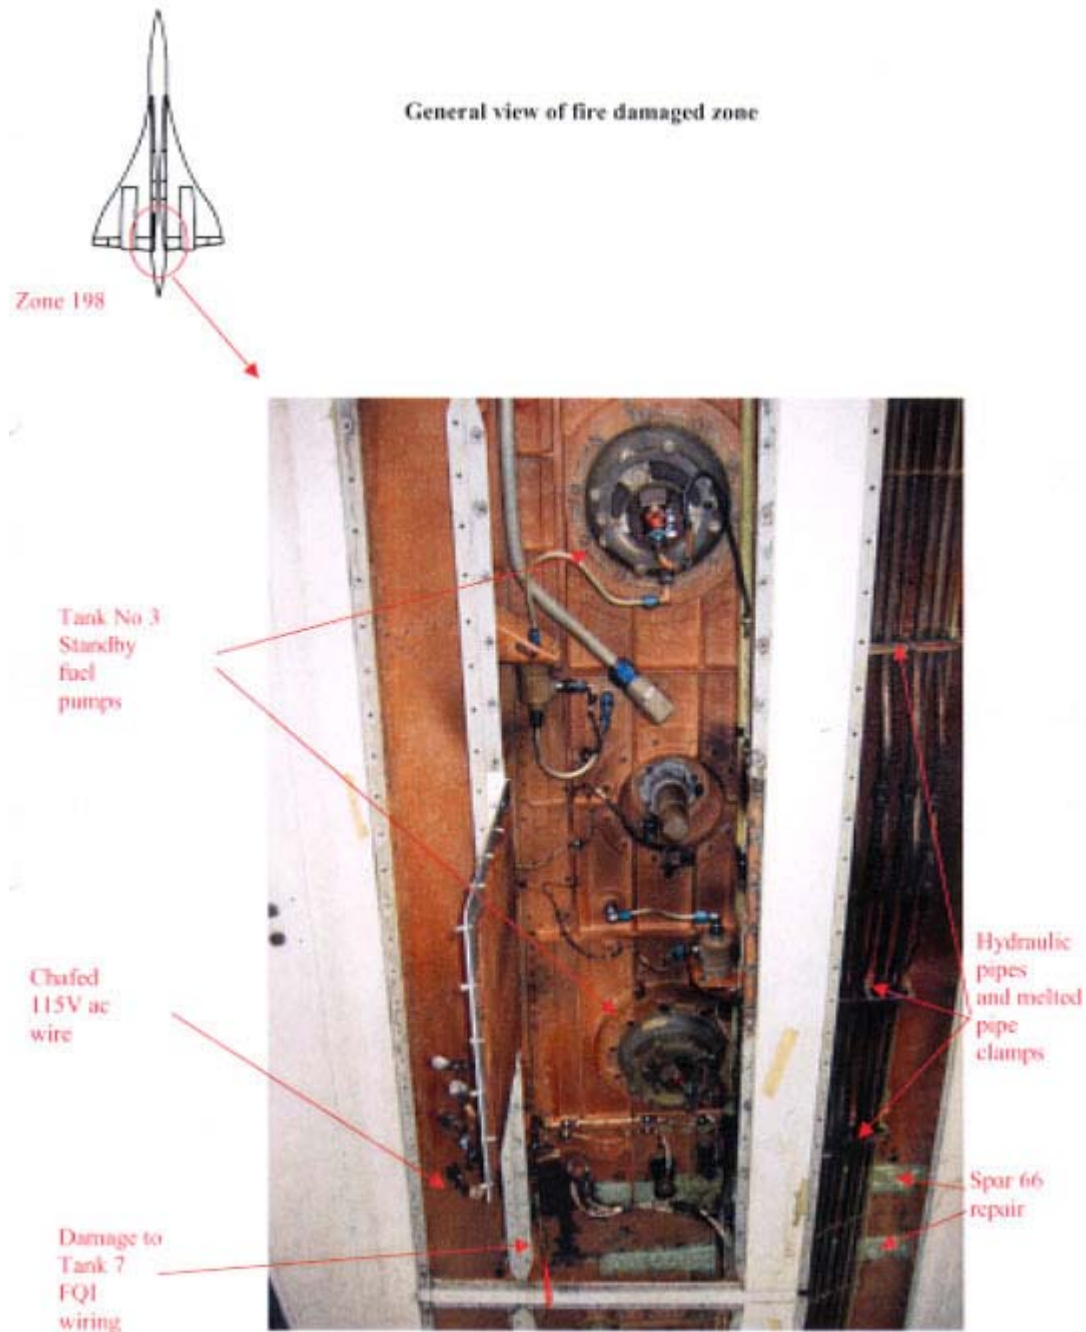
Figure 2: General view of fire damaged zone

The area damaged by the fire was contained within the wing/fuselage fairing area aft of the main landing gear, below and adjacent to tank No 3 (zone 198), Figure 2.

This area contains a number of hydraulic pipe runs, together with wiring for the fuel pumps and FQIs. There was little overall evidence of sooting, indicating that only a small quantity of fuel had been consumed. There was more localised evidence of sooting within a 'box' fairing support structure, and this also showed evidence of a ventilation airflow direction through the area, indicating that the fire was likely to have occurred during flight. Conductivity testing on the aluminium 'box' fairing structure showed this area had been heat affected. There was little damage to the paint and thus the

temperature of the fire was estimated to have been approximately 400°C. Tank No 3 115V AC main fuel pump wiring, from the rear fuselage, was found to be loose within its bundle in this zone and one wire had chafed on fairing panel 198AB, Figure 3.

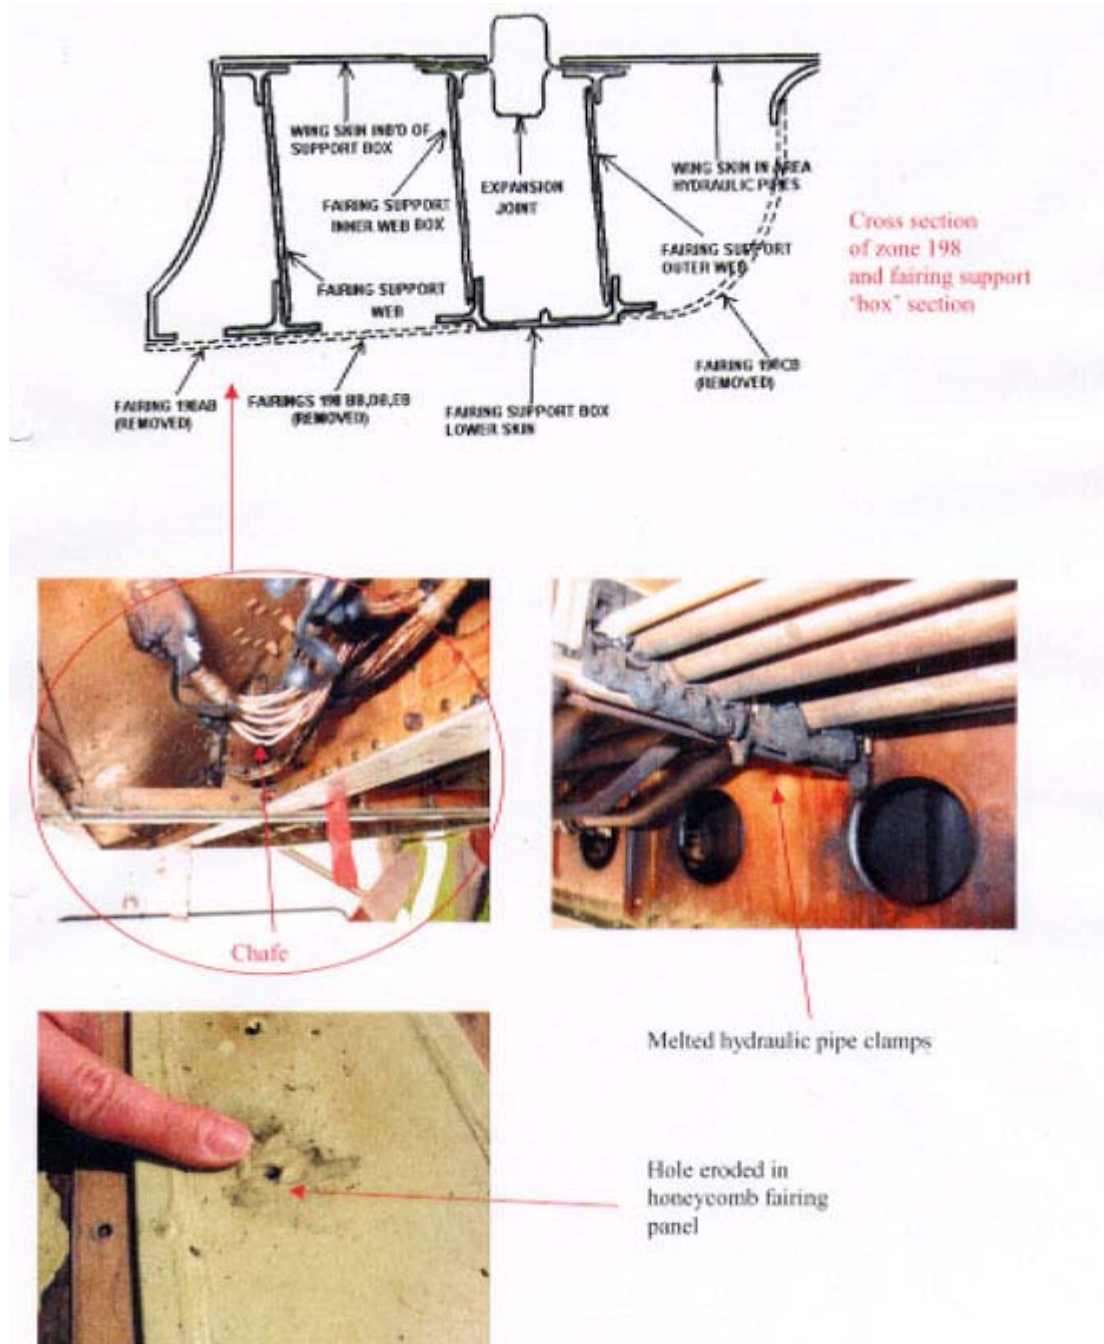
Figure 3: Cross section of Zone 198

The chaffing of the wire on the inner aluminium skin of the honeycomb filled panel eventually led to an electrical arc of a 115V AC supply, which ignited the fuel/air mixture. The fire had also caused damage to the FQI wiring, leading to the reported defects, initially on tank No 7 FQI system and then on other tank FQI systems and the CG computer. Although there was fire damage to the FQI and No 3 fuel pump wiring, there was no evidence of arc-tracking along the length of the wires. Arc tracking is not a feature associated with the Concorde PTFE wiring insulation.

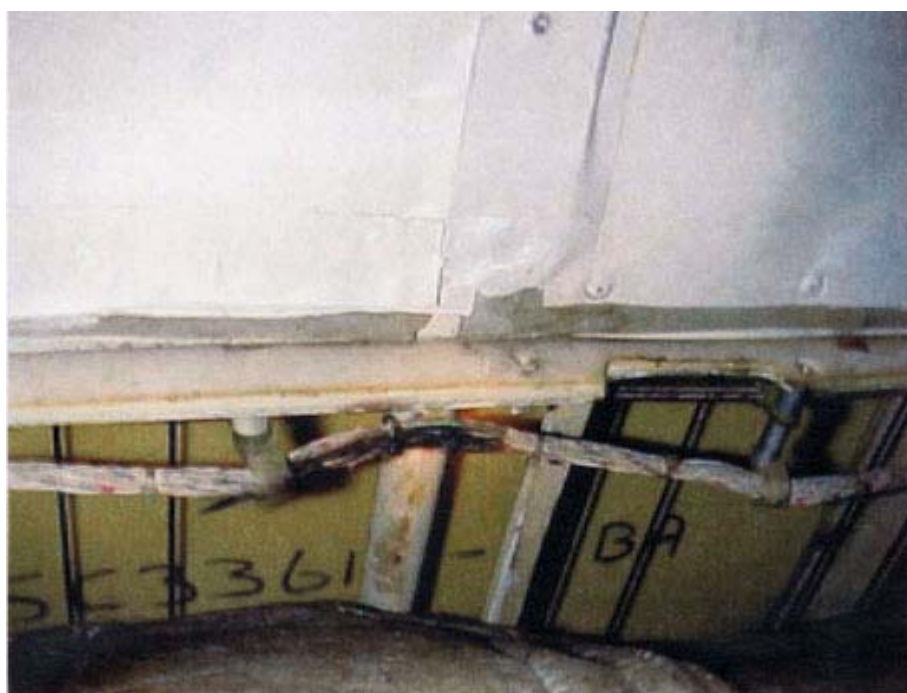
Figure 1: Loom damage

Figure 1 Loom Damage

The wire loom that was damaged, W298, contained all the wires between the pressure controller and the OFV. This meant that the wiring associated with all four modes of operation was included in the same loom. Wires which connected to the aft drain mast heater, the aft door warning system and the

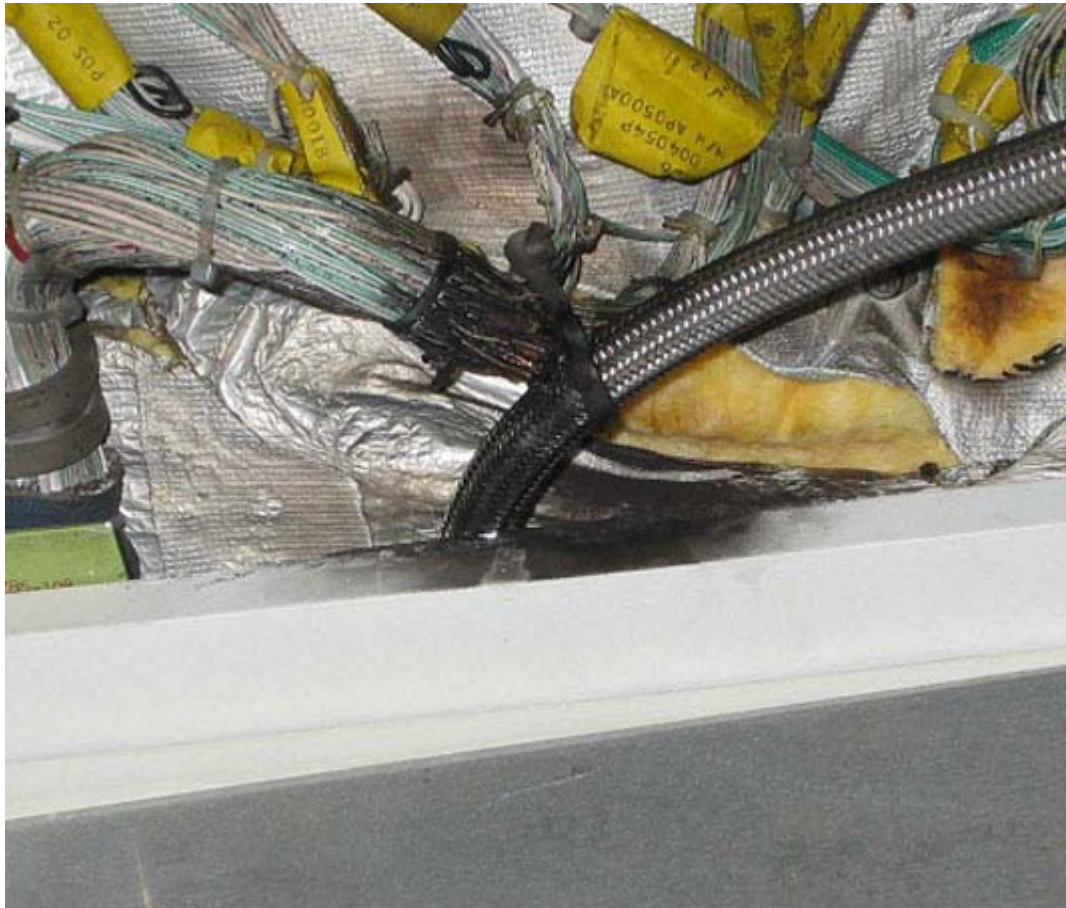
Figure 1: Damaged loom and hose, G-DOCH

The visible damage to the aircraft was found principally in the area above the 'drop-down' ceiling panel immediately aft of the flight deck door, Figure 1, in the forward vestibule of the cabin: this panel is hinged on the left side and secured by two latches on the right side. There was also some scorching and sooting of this panel and around the top of the cockpit door frame.

Figure 1 Damaged loom and hose, G-DOCH

Within this area, damage had occurred to a wiring loom where a braided steel hose had been secured by means of a single electrical 'tie-wrap' strap (the generic cable tie system formed of nylon-type UV-resistant material). It appeared that there had been abrasion and arcing between the wires and the hose, resulting in the severing and shorting of a number of the wires. The braided steel hose was lying against the frame of the ceiling panel and it appeared that there had also been electrical shorting to this portion of the airframe.

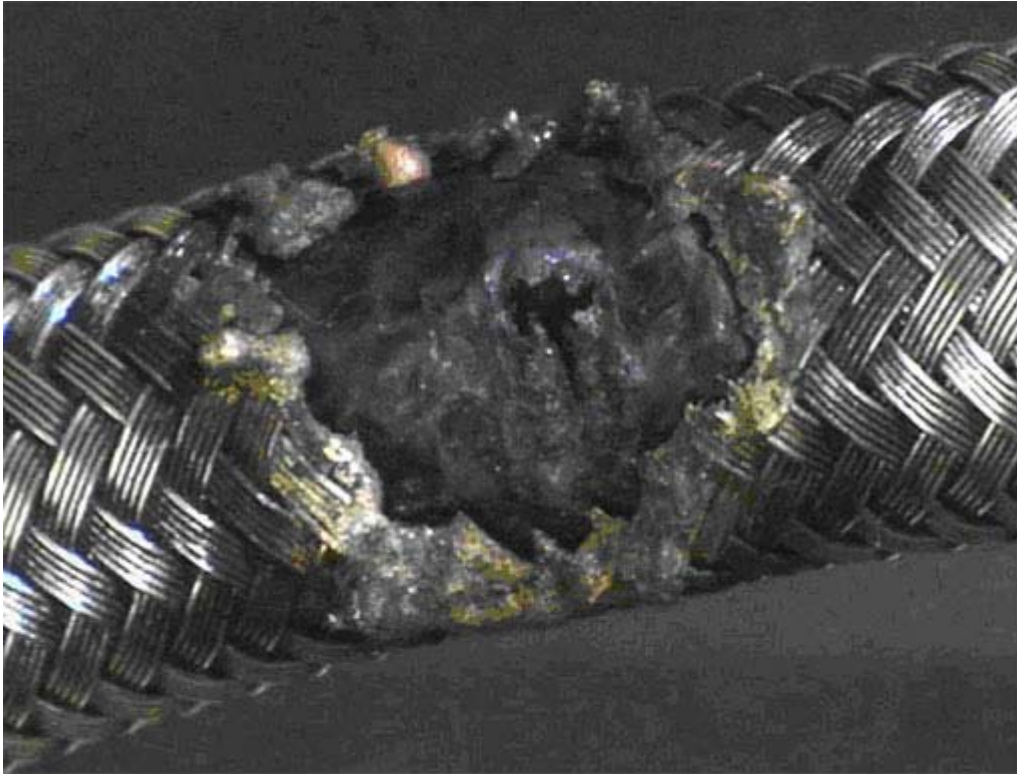
Figure 2: Damaged hose, G-DOCH

The hose involved was a water hose which supplied potable water from an aircraft connection in the crown of the fuselage, to the back of the No 1 galley; this was located at the right-hand side of the forward cabin. An area of this hose in which the steel braid appeared to have melted, was apparent, and at least two holes had been created in the PTFE inner hose, Figure 2, which resulted in the substantial water leak.

Figure 2 Damaged hose, G-DOCH

Comparison with a sister aircraft, G-DOCW, indicated that the hose was too long for this application and that the extra length in G-DOCH had been looped through this overhead area and then only secured by a tie-wrap to adjacent wire bundles. Part of the hose was protected by plastic spiral wrap but this did not extend to the portion of the hose in contact with the wire bundles.

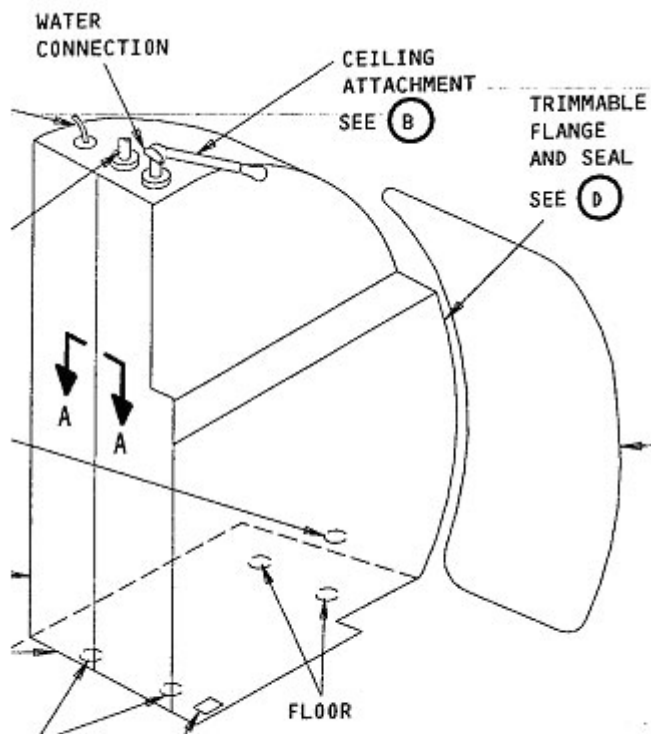
Figure 4: Illustration from aircraft Maintenance Manual

but the associated diagram, Figure 4, showing a generic galley unit, labelled the water connection as being on top of the galley and did not indicate any hose between this connection and the point in the aircraft ceiling at which it should be disconnected.

Figure 4 - Illustration from aircraft Maintenance Manual
Generic diagram identifying water connection. No information concerning supply hose
or its method of installation

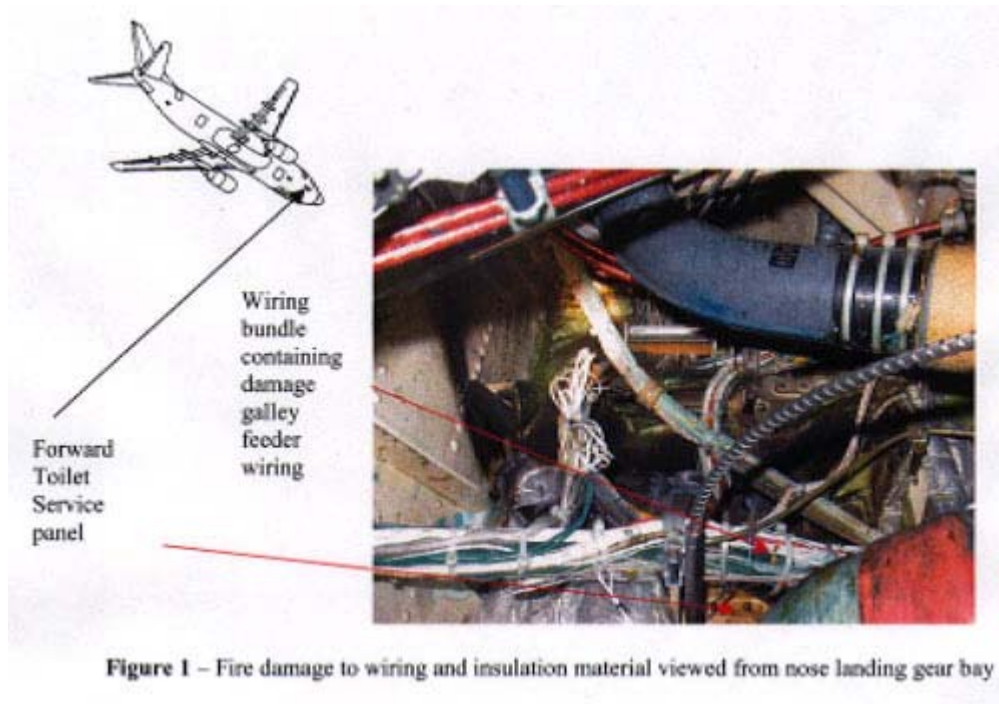
Figure 1: Fire damage to wiring and insulation material viewed from nose landing gear bay

Some fire damage was observed inside the fuselage on the right side of the aircraft, in the area of the forward toilet service panel, beneath the cockpit floor and forward of the Electrical and Electronic compartment (see Figure 1). The area contains the toilet servicing ducts as well as inertial reference units and numerous wiring bundles. Included in the list of systems affected by the damage were; autothrottle system, digital stall warning system, engine idle control, engine ignition, thrust reverser control (No 2 Engine), right wing slat and flap indicating systems, altitude information from Air Data System No 2, Inertial Reference Systems, EFIS power and weather radar.

Figure 1 – Fire damage to wiring and insulation material viewed from nose landing gear bay

There was evidence of dried blue fluid (toilet sanitising fluid) contamination indicating that there had been leakage from the toilet charge pipe in the area of the forward toilet service panel. The ground engineer also reported that the area has been wet from the ingress of moisture from rainfall the previous night when the integral airstairs had been used. The APU had been run for a period of 20 minutes in order to dry the underfloor area before resetting the Circuit Breakers.

A short duration flash fire had apparently occurred; there was evidence of fire having consumed some of the aircraft insulation material. The majority of the wiring bundles from this area were insulated with polyimide (Kapton). Some of these wires had separated and examination showed evidence of damage from heat and arcing but there was no evidence that the wires had been contaminated or chafed prior to the fire. Similarly, there was no evidence on the adjacent structure that chafing or arcing had occurred. However, examination of the 10 gauge Boeing Material Specification (BMS) 13-31 3-Phase 115V AC galley power feeder cables did show evidence of some pre-existing damage (see Figure 2). The insulation material for these cables is a mineral filled polytetrafluoroethylene (ie Teflon).

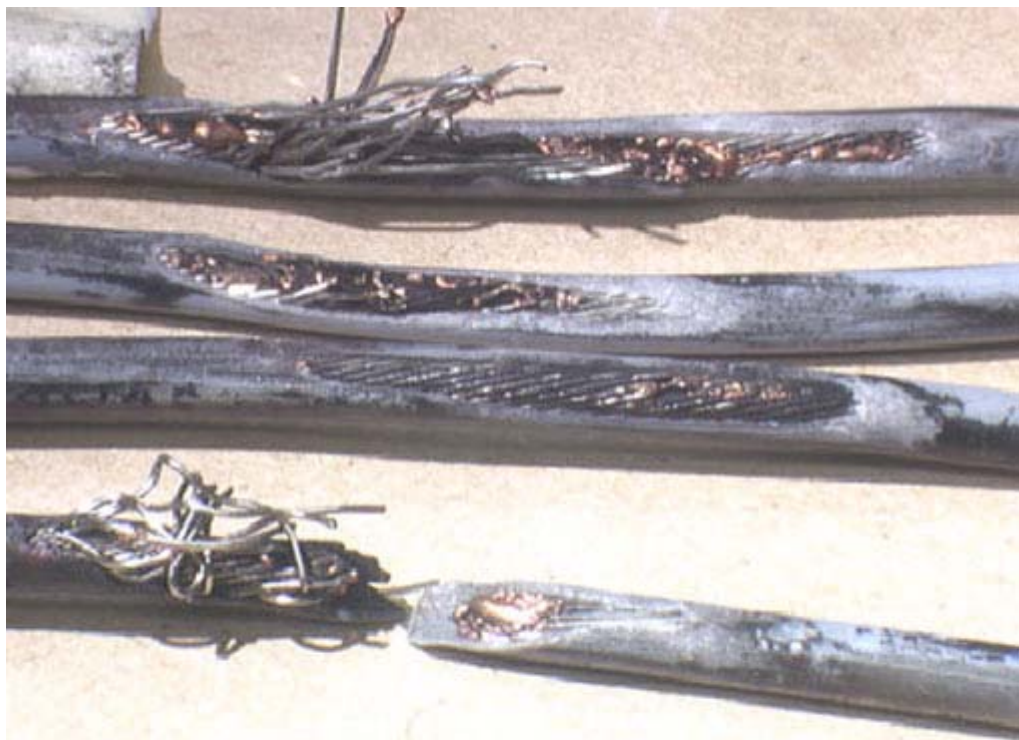
Figure 2: Damage to galley power feeder cables

Figure 2 - Damage to galley power feeder cables
