Shorted wiring/forward cargo door rupture/explosive decompression/inflight breakup explanation described in pictures, text, and drawings for United Airlines Flight 811, Pan Am Flight 103, Air India Flight 182, and Trans World Airlines Flight 800.

John Barry Smith 22 March 2002

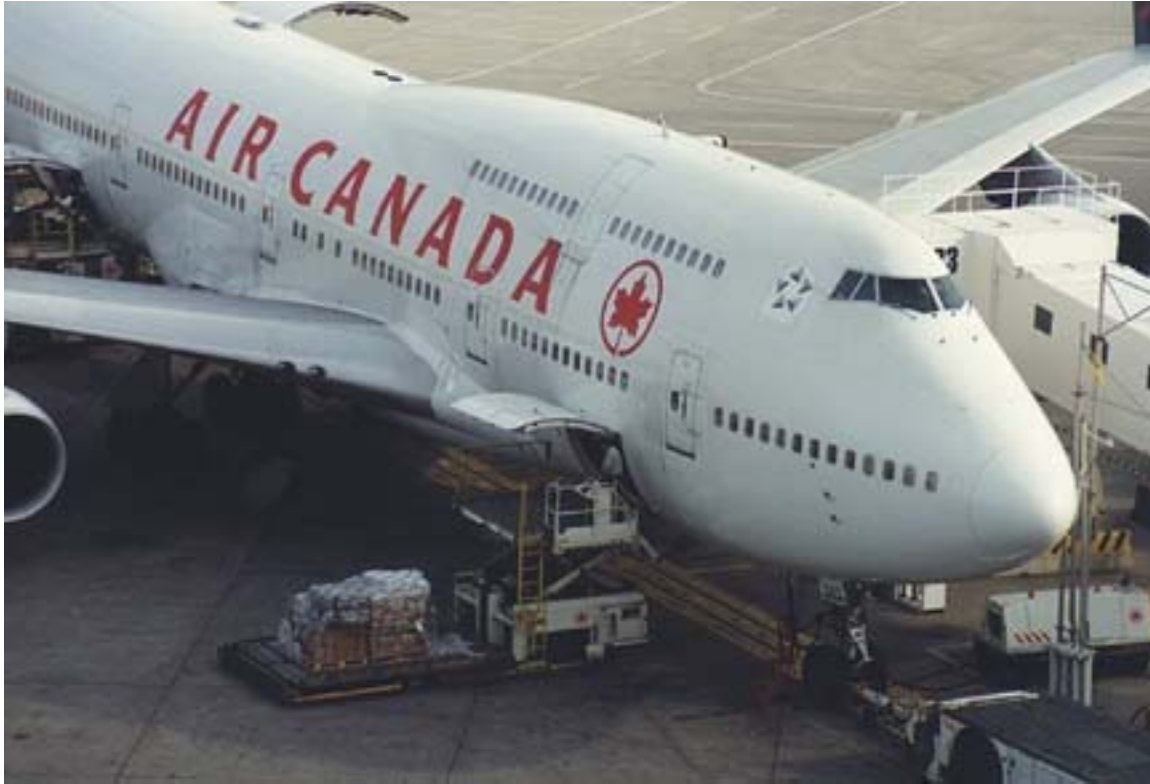
Caption for above photograph:  
Boeing 747 on ground loading cargo through opening outward nonplug forward cargo door. The tiny dot of the one midspan latch on the leading edge of the door can be seen.

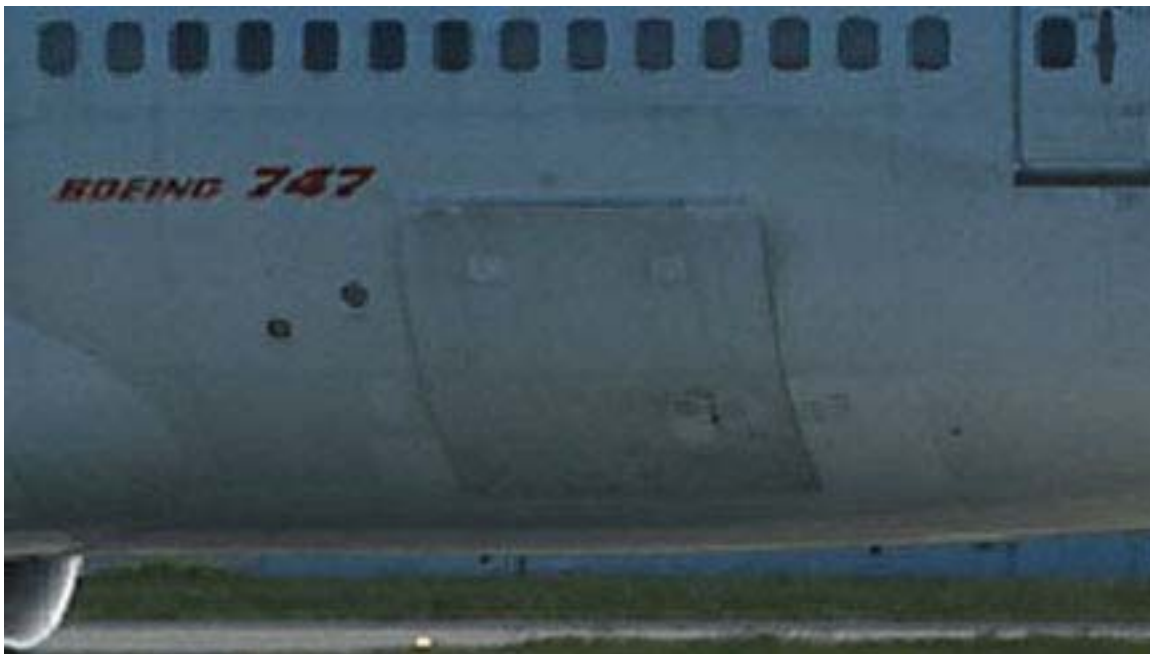
Caption for above photograph:  
Closeup of Boeing 747 closed forward cargo door showing manual locking handle, upper hinge, over pressure relief doors, engine number two, passenger windows above door, and R2 door.

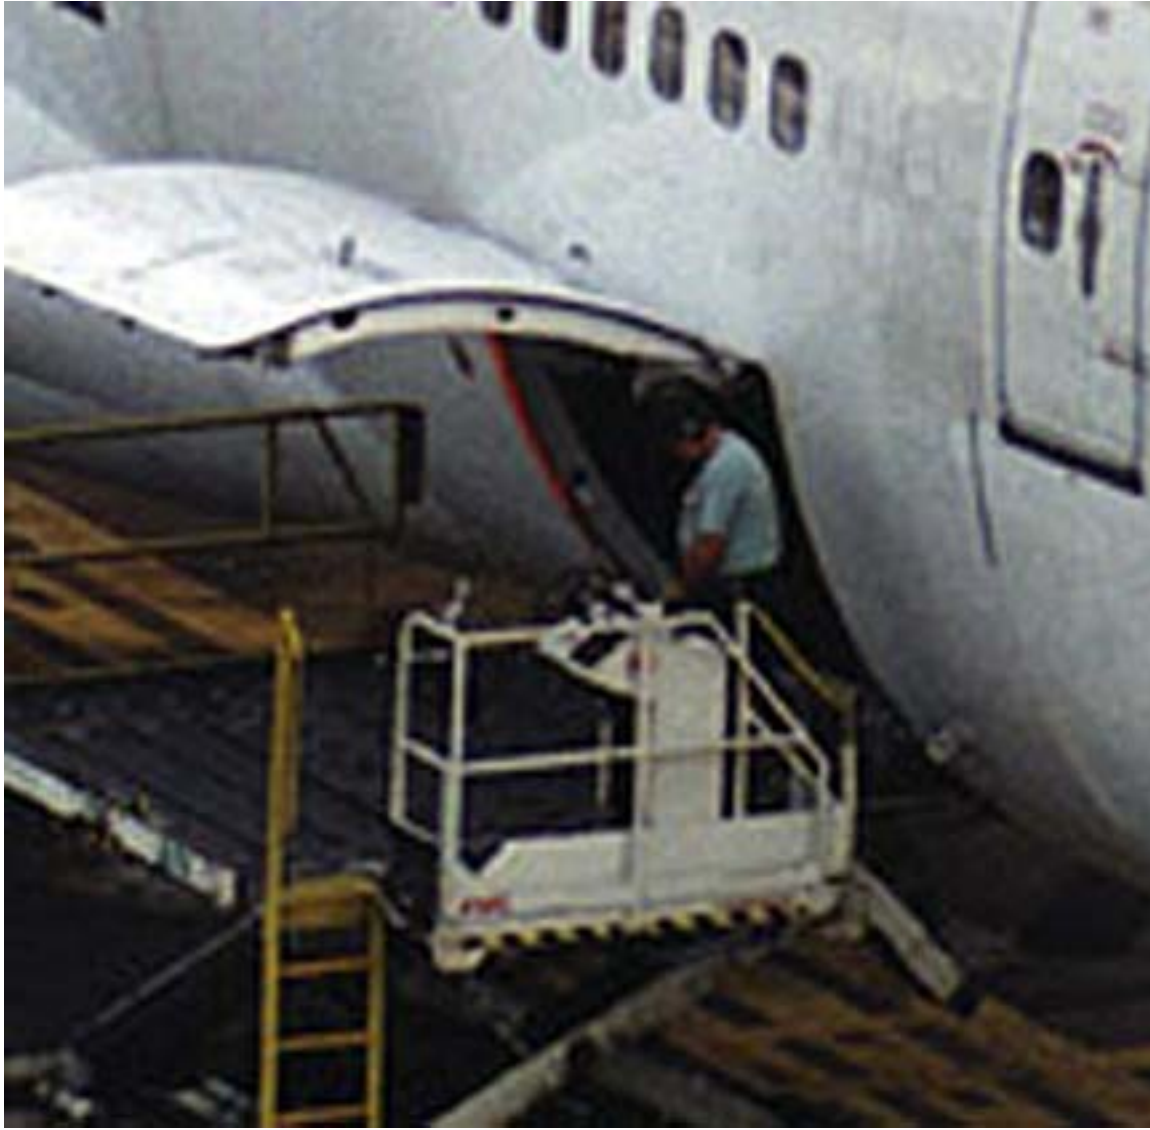
Caption for above photograph: Closeup of open forward cargo door showing open manual locking handle, several of the bottom eight latches, forward leading edge midspan latch, and the aft leading edge midspan latch pin.

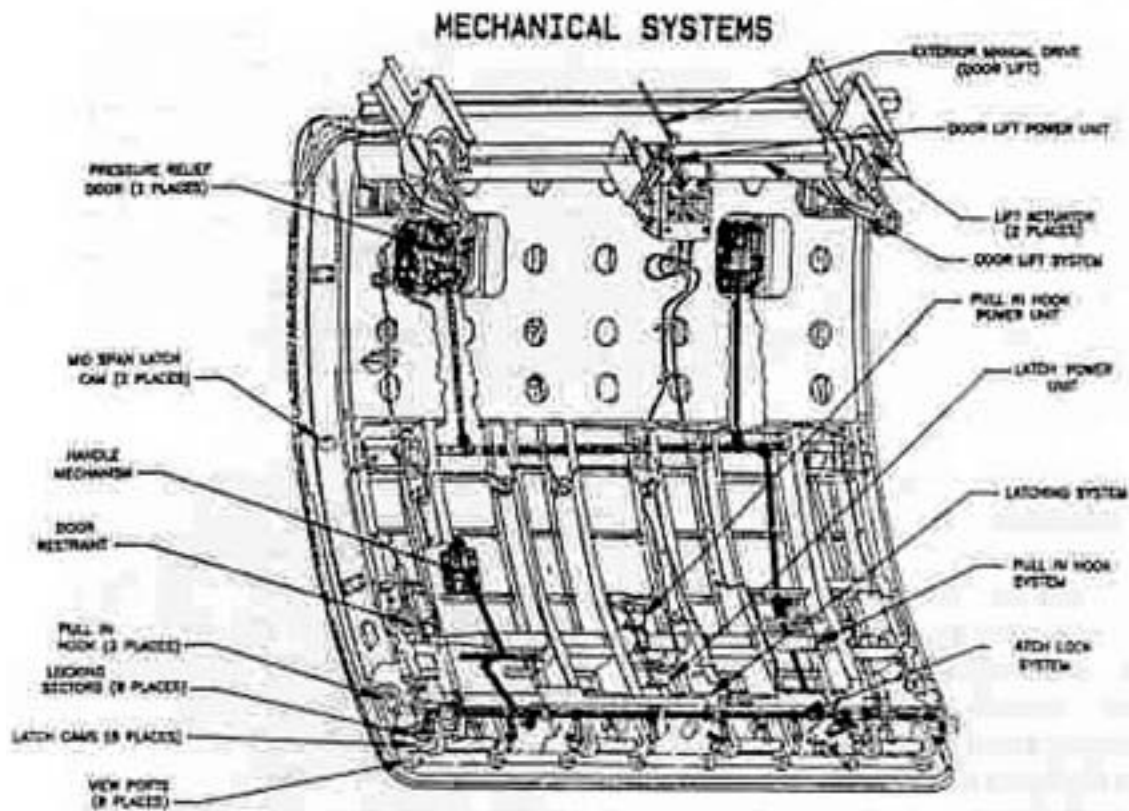
Caption for above drawing and below description of operation of cargo door: Drawing of Boeing 747 cargo door from NTSB AAR 92/02.

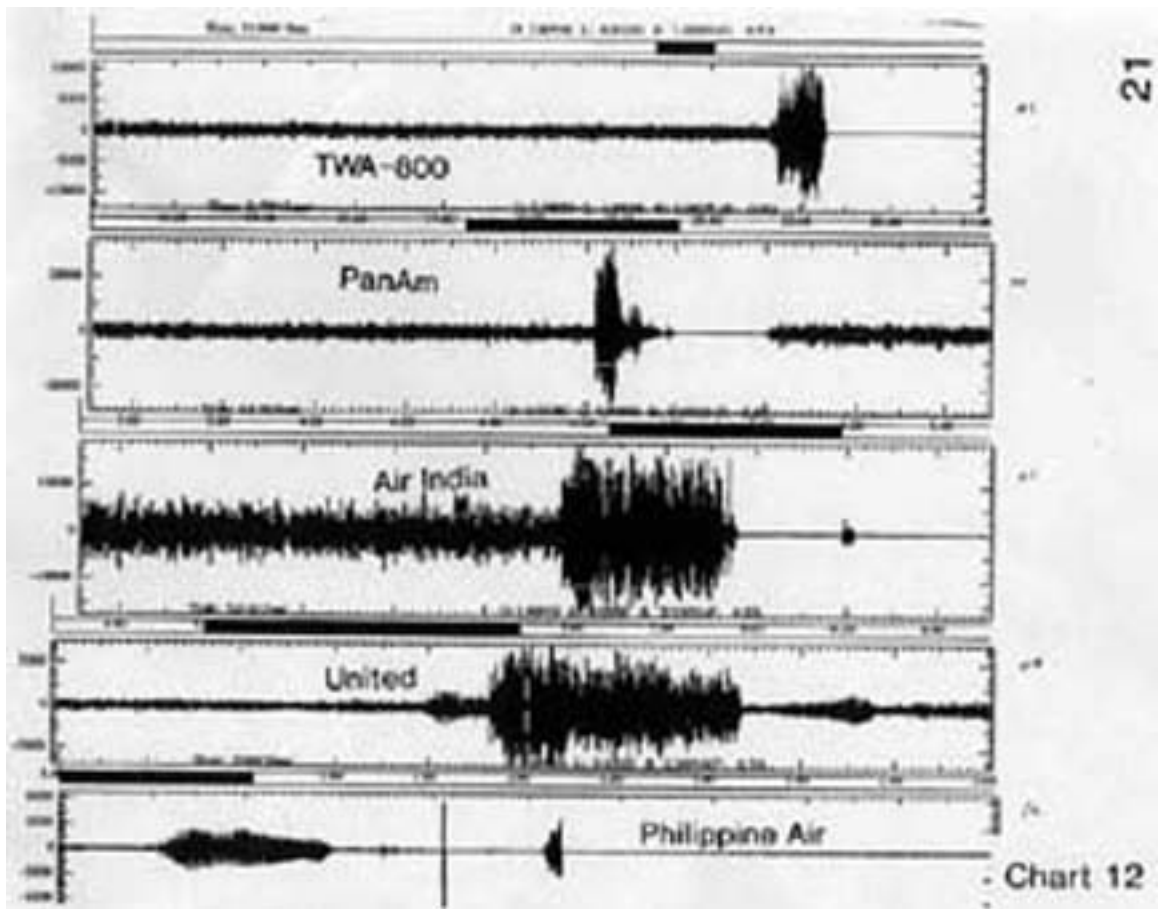
Caption for above Chart: Chart 12 from Public Docket for Trans World Airlines Flight 800 comparing the sudden loud sounds from Trans World Airlines Flight 800, Pan Am Flight 103, Air India Flight 182, United Airlines Flight 811 and a Boeing 737.

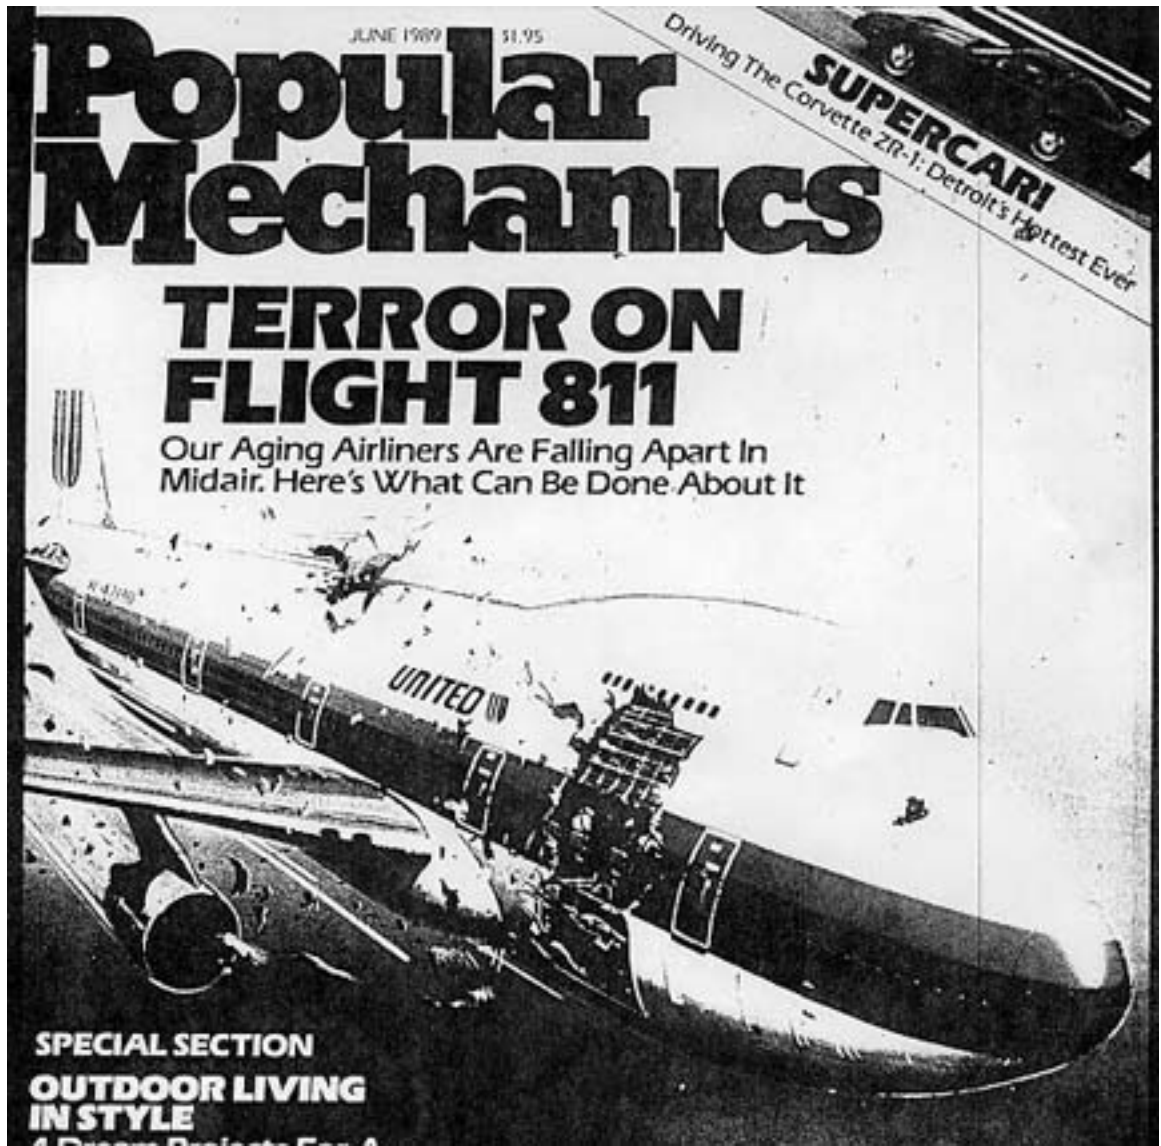
Caption for above drawing: Sensational artist's impression on cover of June 1989 Popular Mechanics showing United Airlines Flight 811 as it descends to land after inadvertent opening of forward cargo door in flight.

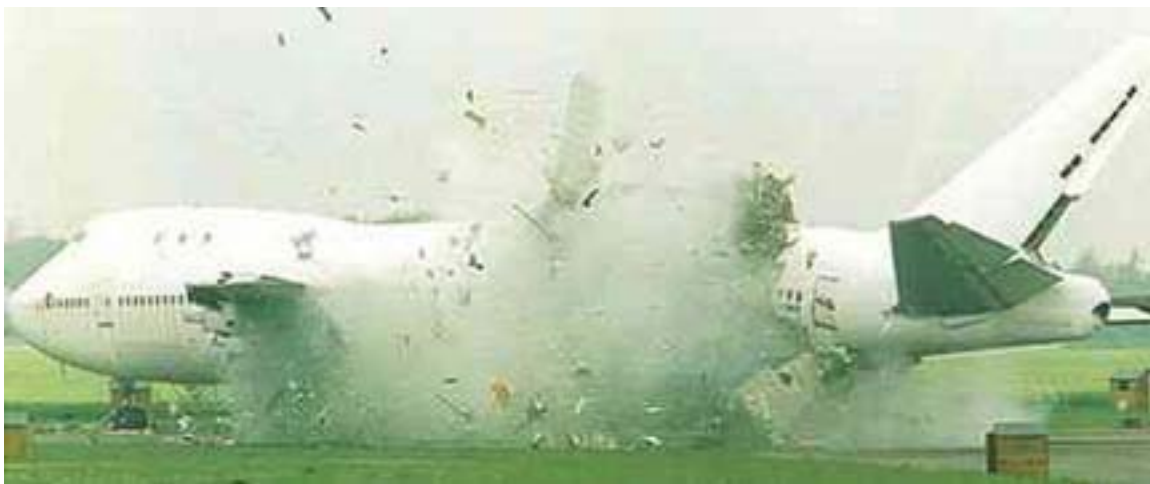
Caption for above photograph: Staged bombing of a Boeing 747 at Bruntingthorpe UK showing the massive damage which occurs when a real bomb goes on in a Boeing 747.
