AIRCRAFT OCCURRENCE INVESTIGATION REPORT

Air India Flight 182, "Kanishka"
Boeing 747-237B, VT-EFO

by: John H. Garstang

16 March 2001

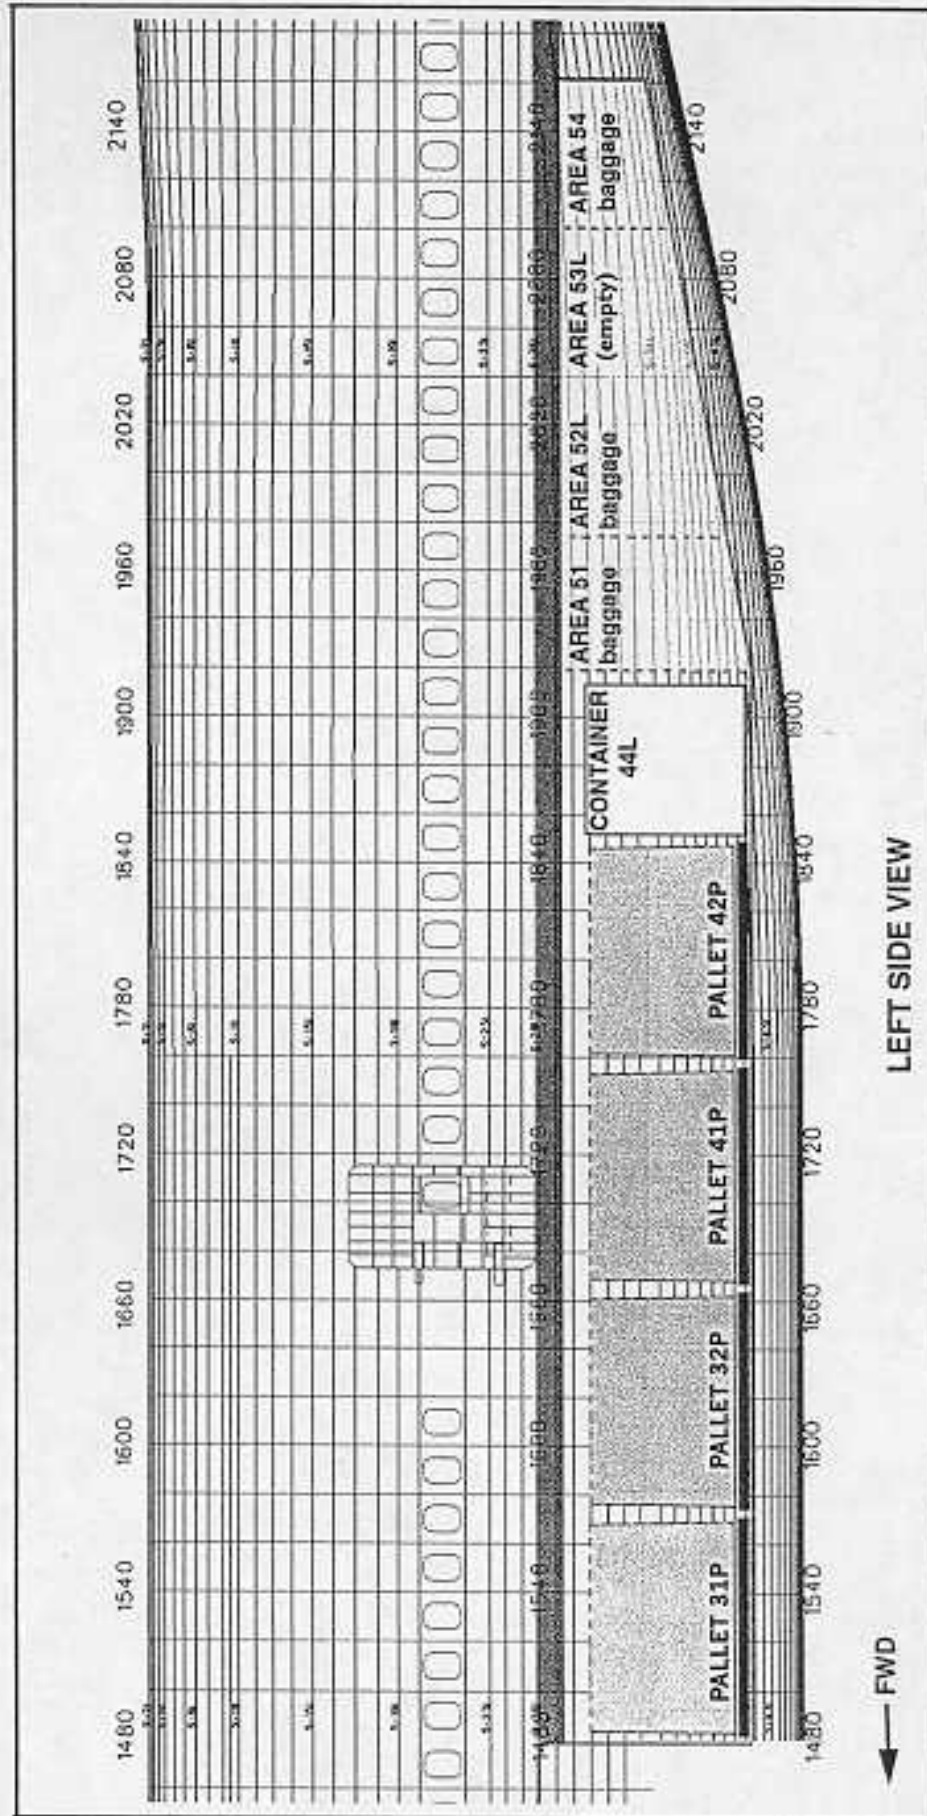
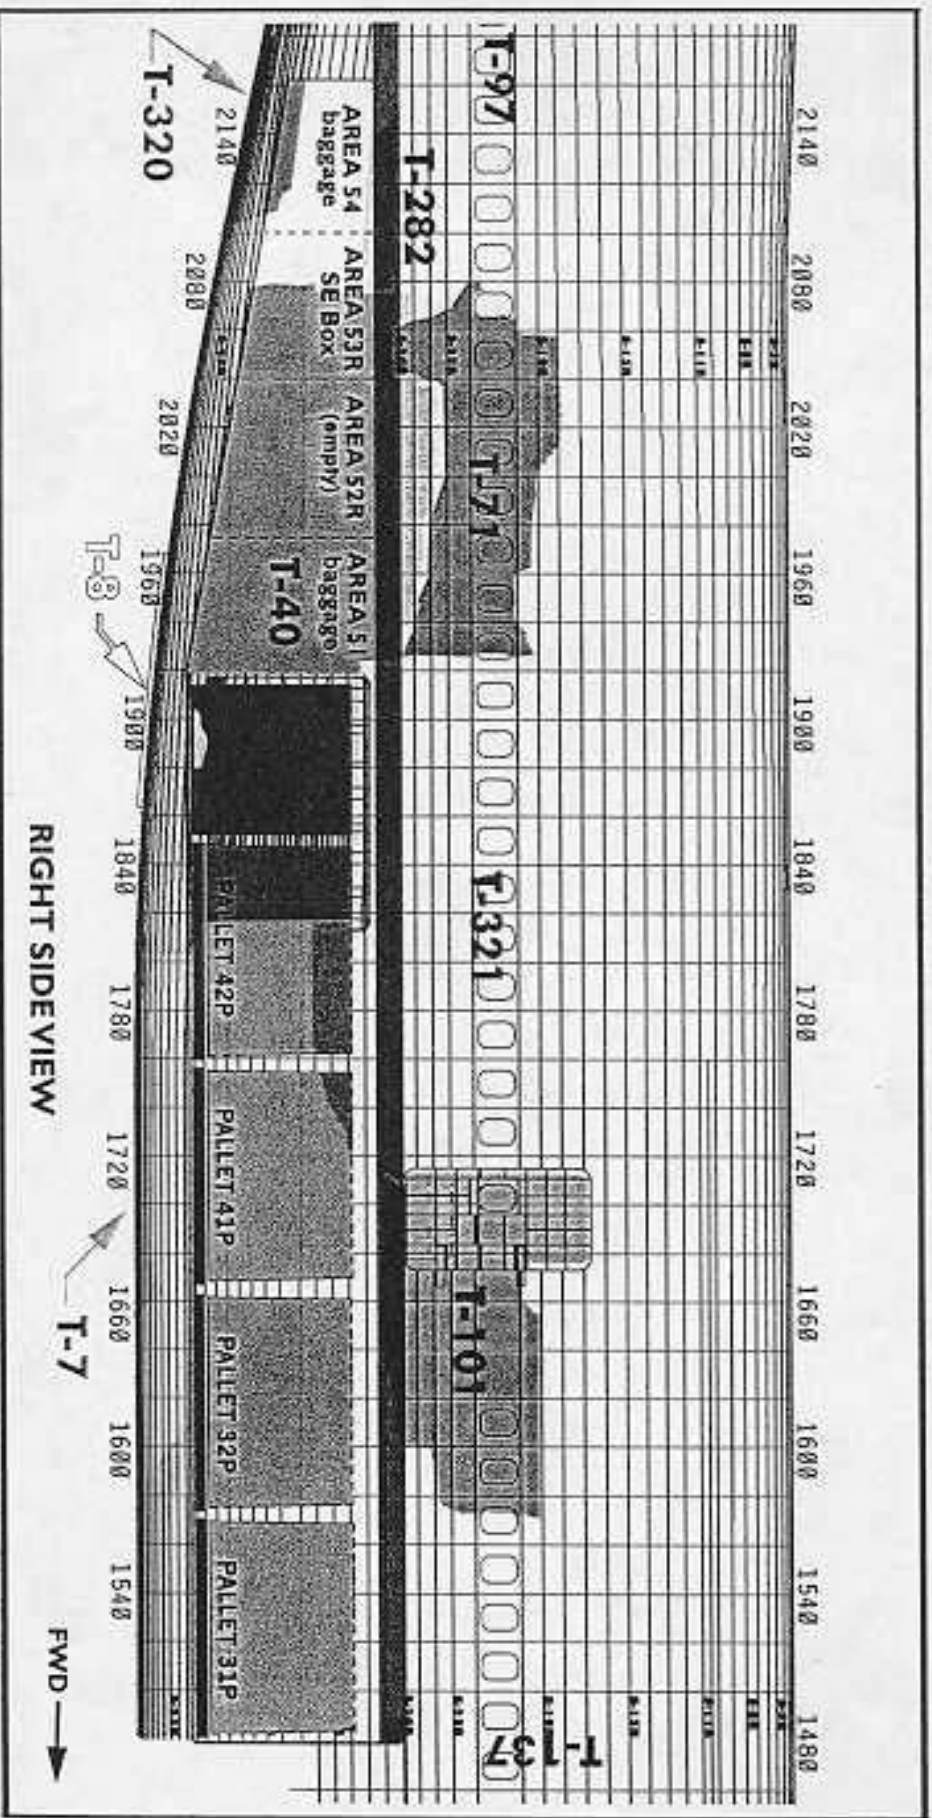
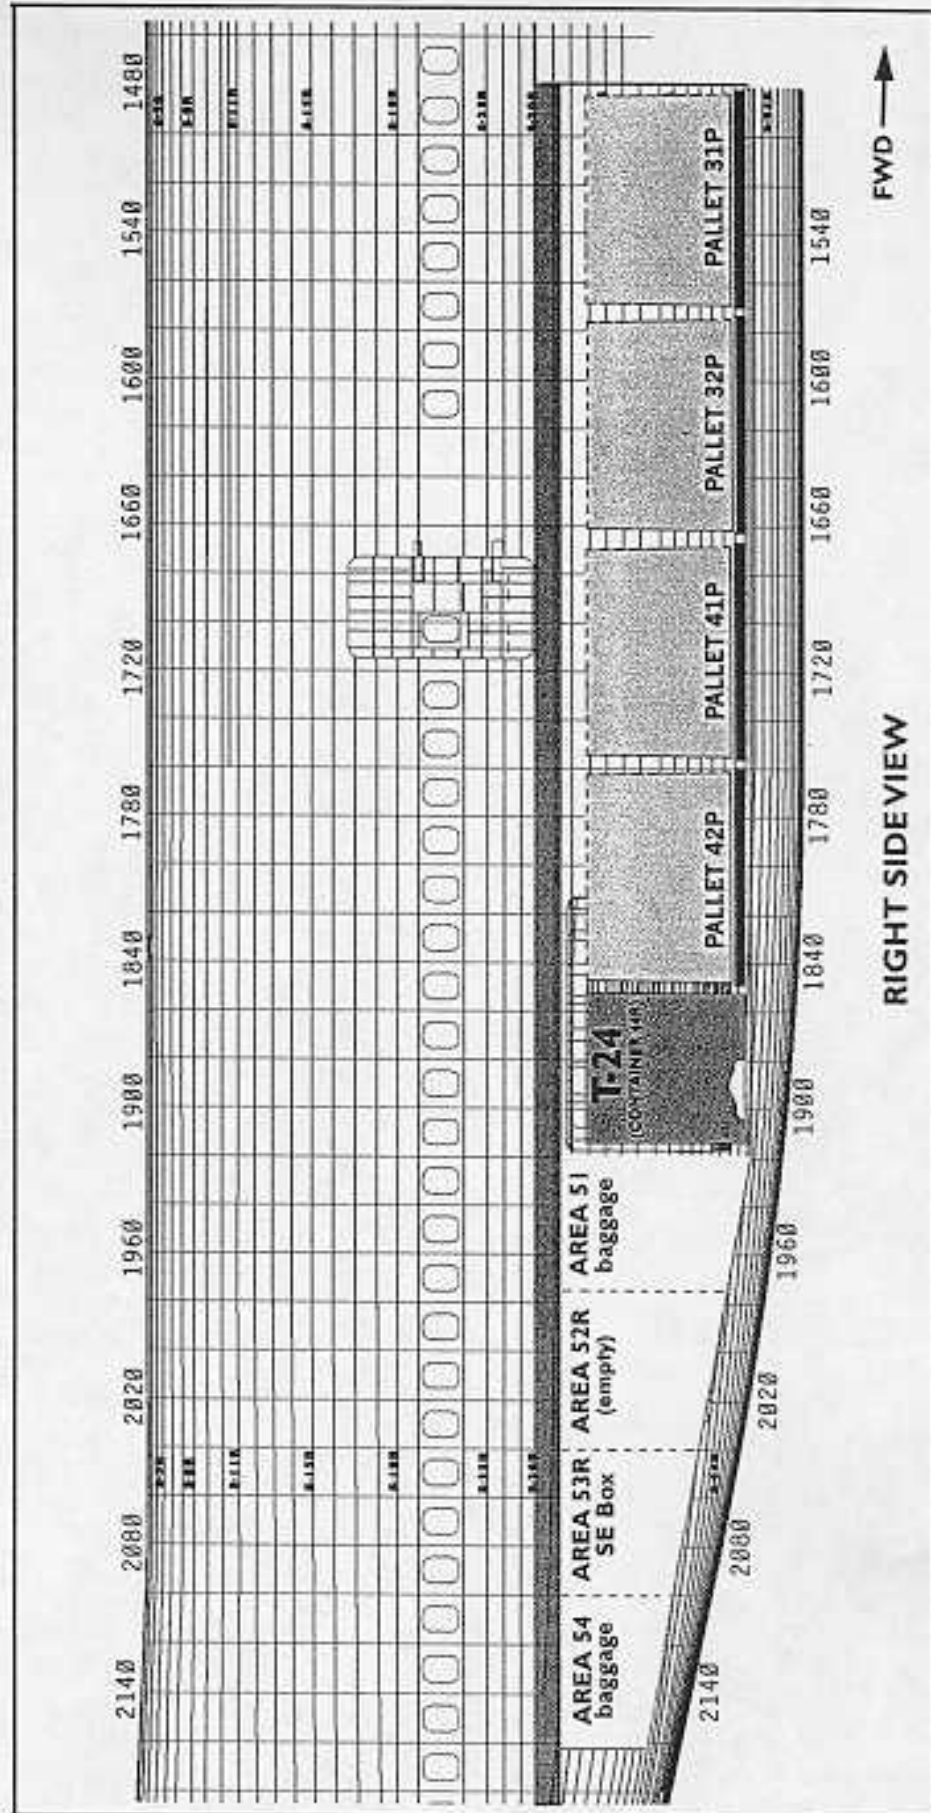
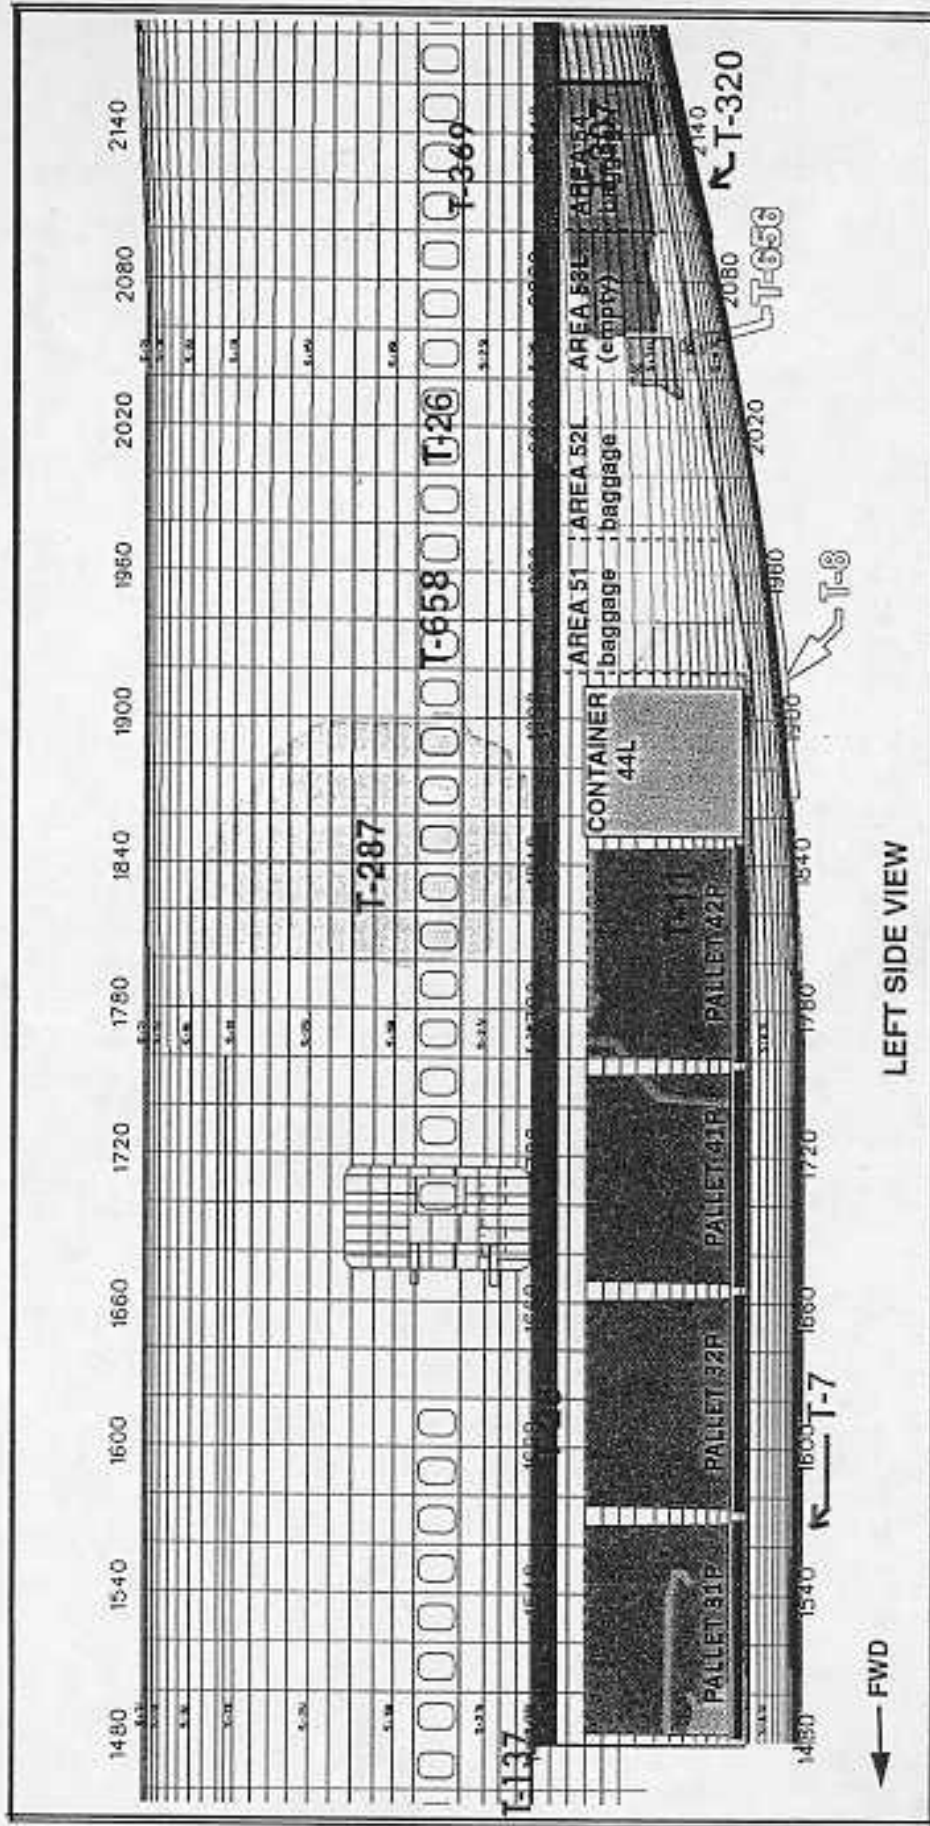
**AFT FUSELAGE SHOWING SKIN TARGETS,
PALLETS, BAGGAGE CONTAINERS
AND BULK CARGO REGIONS**

The overall deformation pattern of the exterior skin on the bottom and both sides of the rear fuselage, which exhibited petals or curls and the outward bulging of structure, is consistent with damage generated by the rupture and venting of internal overpressure(s) outward from the aft cargo and bulk cargo compartment areas.

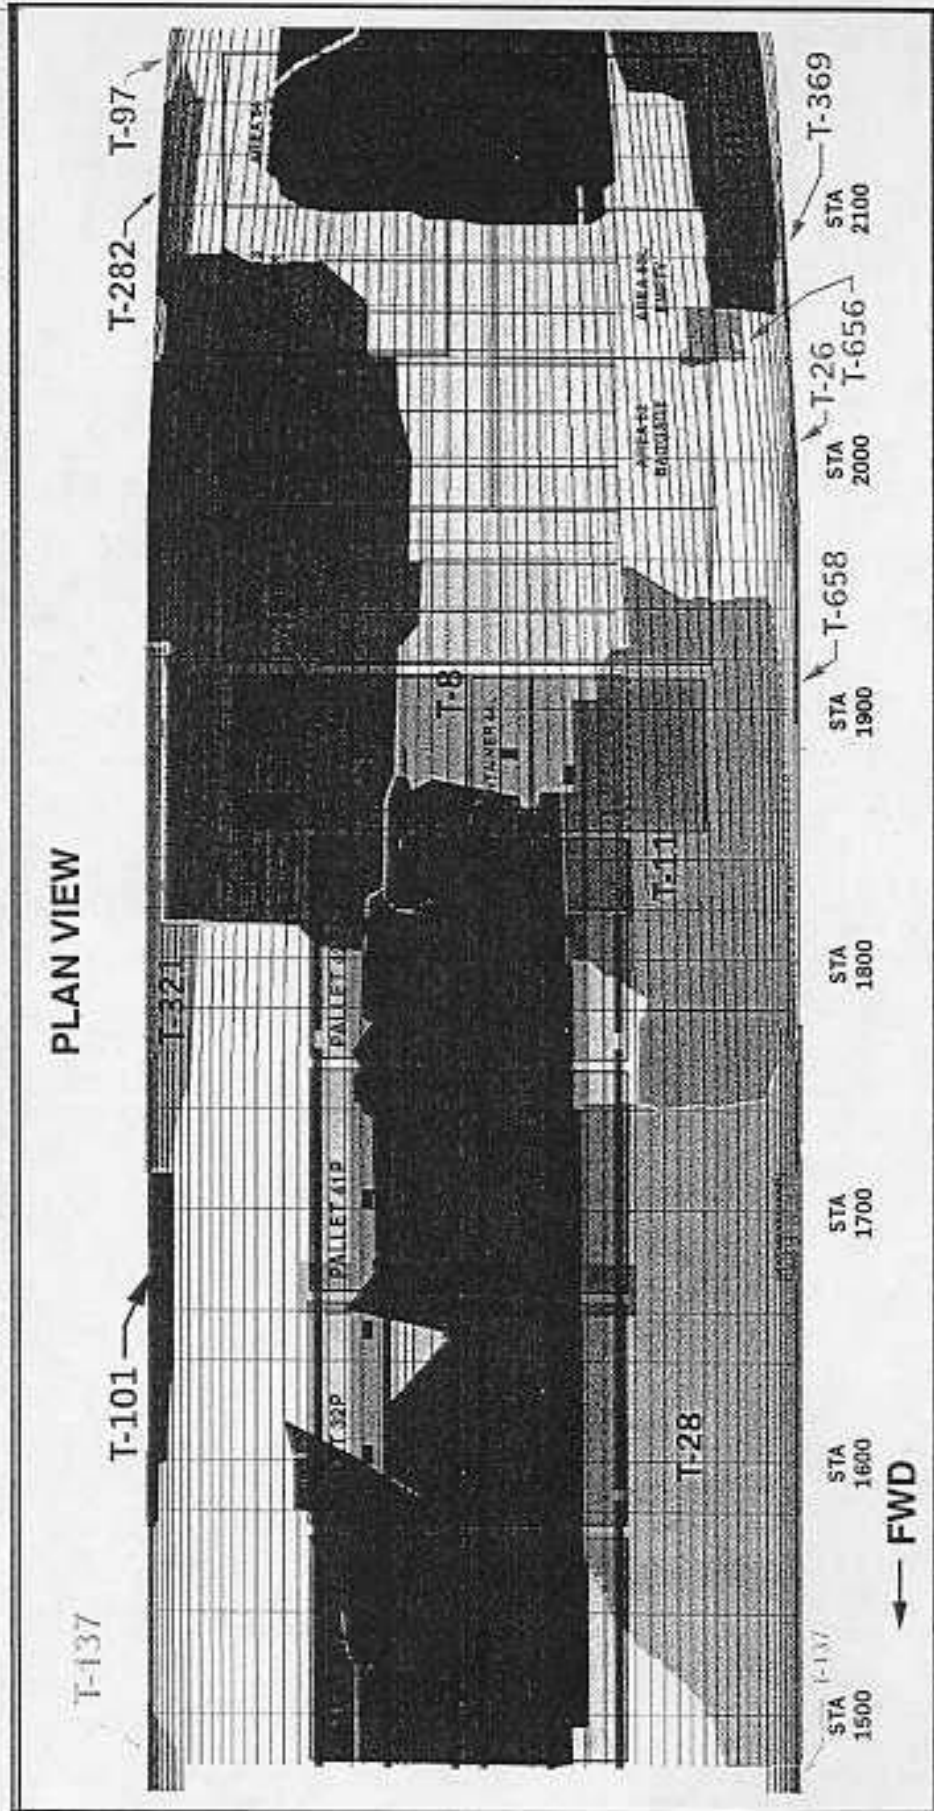
AFT CARGO AND BULK CARGO COMPARTMENTS
WITH
FUSELAGE SKIN TARGETS, CARGO FLOOR, AND CARGO

Analysis indicates that the sudden and catastrophic loss of the aircraft was due to the overload failure of the aft cargo compartment and the bulk cargo compartment as a result of sudden, large, internal overpressure load(s). The only plausible way to do this rapidly, and in the manner previously described, is by the detonation of a bomb (improvised explosive device). The evidence I have examined is consistent with this.

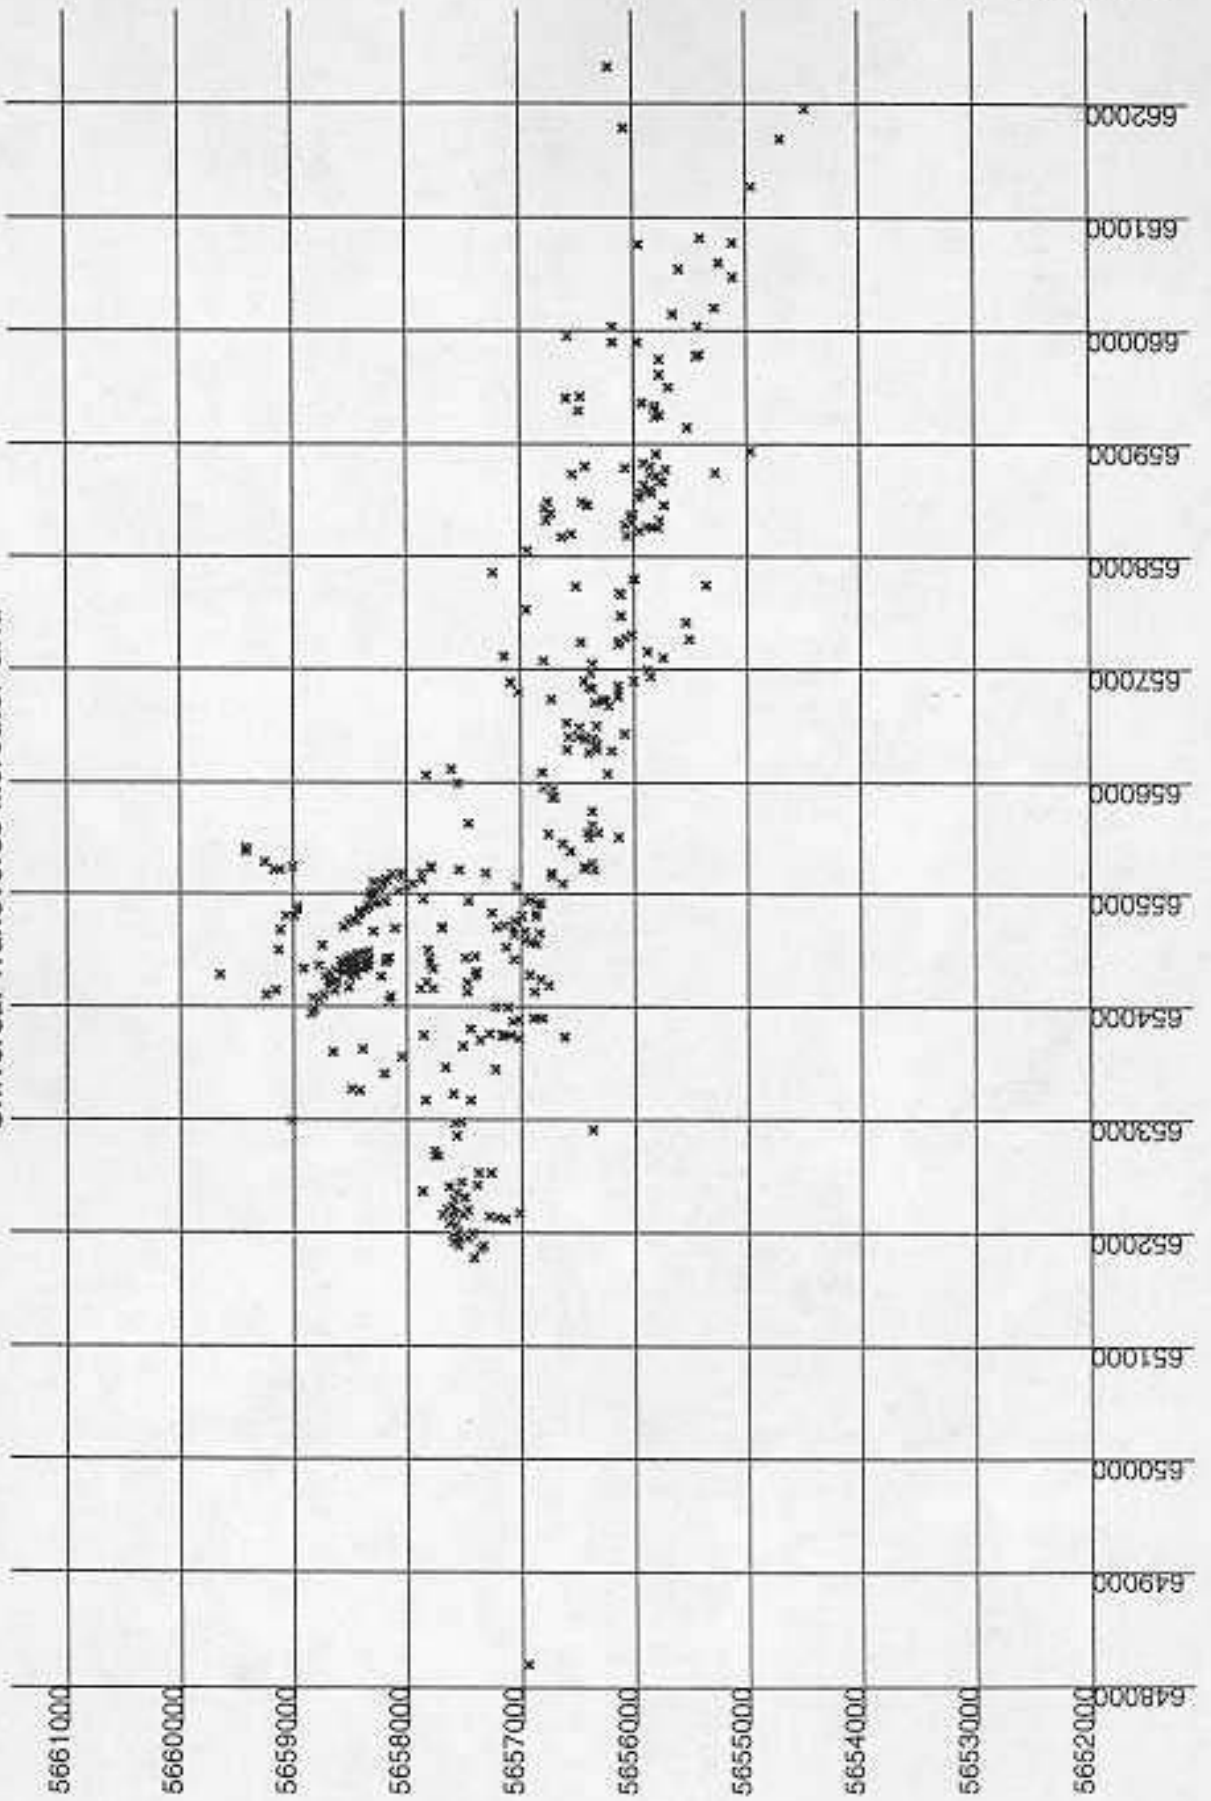
Plot of All Targets
Universal Transverse Mercator Grid

It is significant to note that the very first item found (the most Westerly part) was a tom suitcase (target "1A!"). This suitcase was situated approximately 3 1/2 kilometres West from the Western edge of the main debris field. Since it was found so early along the flight path, it is consistent that this is one of the very first items to have separated from the aircraft. In order for this to take place it is likely that an opening in the fuselage occurred at a location where a suitcase was in proximity to the opening, such as in the vicinity of a cargo compartment or overhead locker (if an item of this type would have been allowed to be taken into the passenger compartment as carry-on luggage). In addition, some of the first items to be found at the beginning of the Southern trail were targets "8" (piece of belly skin below the aft end of the aft cargo compartment, extending to the forward end of the bulk cargo compartment), target "7" (large piece of belly skin below the aft cargo compartment) and target "2" (piece of cargo compartment floor from the aft cargo compartment). Based on the trajectory analysis, evidence indicates that the suitcase probably came from the rear of the aircraft, since the first off Southern trail of wreckage was comprised almost exclusively of pieces from the rear of the aircraft. Early breakup of the bulk cargo and aft cargo compartments was indicated by the early presence of targets "6811", "7" and "2" at the beginning of the trail.
